Item #14698444 - Kobelco SK210LC-11 Tracked Excavator

Inspection Report

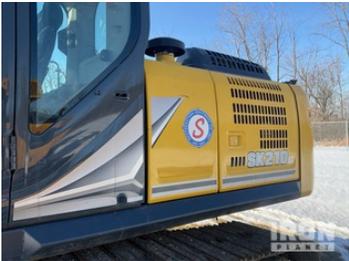
Paint	No visible damage

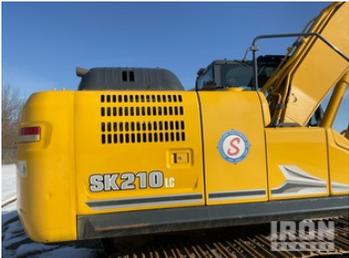
Body Panels	No visible damage or missing components

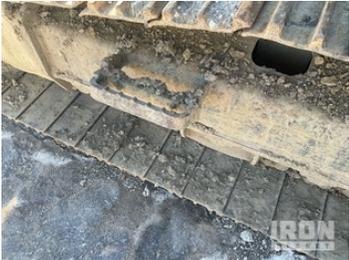
Steps	No visible damage or missing components

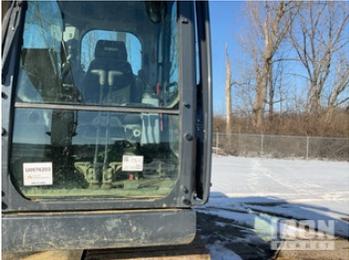
Hand Rails	No visible damage or missing components

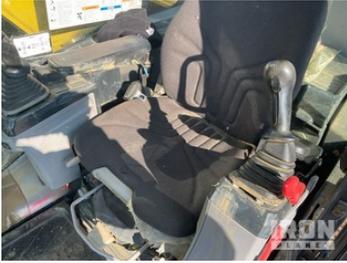
Seat/Armrests	No visible damage or missing components

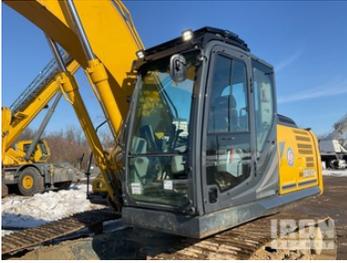
Glass	No visible damage or missing components

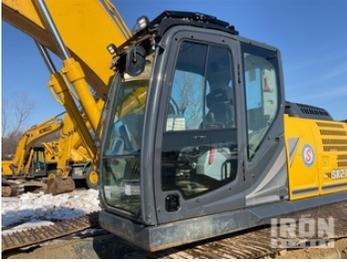
Cab Door	No visible damage or missing components

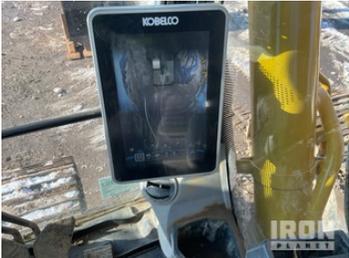
Engine Oil Pressure	No oil pressure indicator	
Warning Lights	Operational

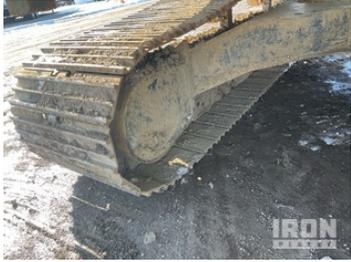
Item	Assessment	Photo
Left Drive Motor	★★★☆☆

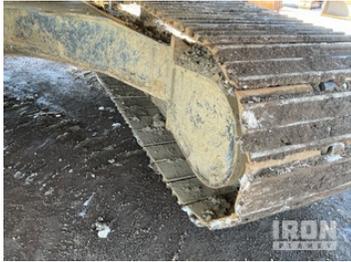
Right Drive Motor	★★★☆☆

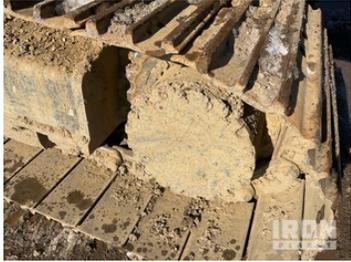
Left Final Drive	★★★☆☆

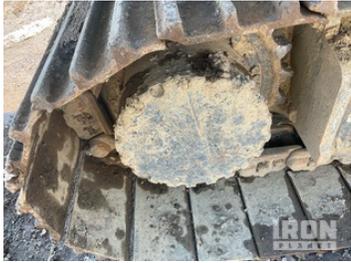
Right Final Drive	★★★☆☆

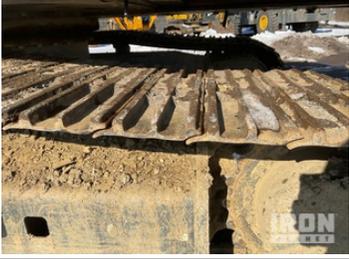
Left Grouser Height	23 mm

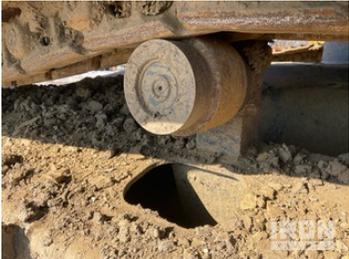
Left Carrier Rollers	2 carrier rollers #1 120 mm #2 120 mm

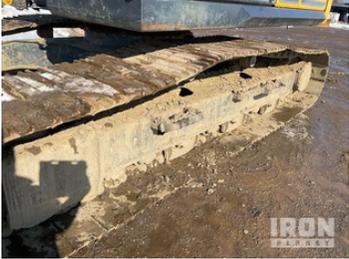
Left Bottom Rollers	8 Bottom Rollers #1 127 mm #2 127 mm #3 127 mm #4 127 mm #5 127 mm #6 127 mm #7 127 mm

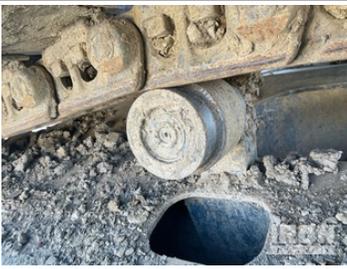
Right Carrier Rollers	2 Carrier Rollers #1 112 mm #2 112 mm

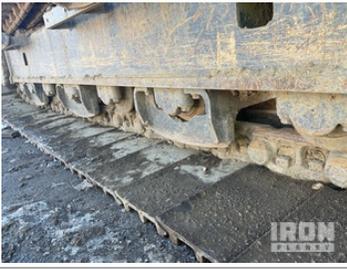
Right Bottom Rollers	8 Bottom Rollers: #1 127 mm #2 127 mm #3 127 mm #4 127 mm #5 127 mm #6 127 mm
