## Item #11535367 - JCB 427 ZX Wheel Loader

# Inspection Report

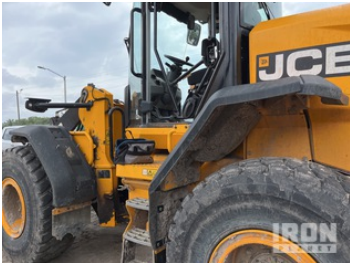
Body Panels	Cab door damaged, Grille damaged, Battery box latch damaged	
Fenders	No visible damage or missing components.

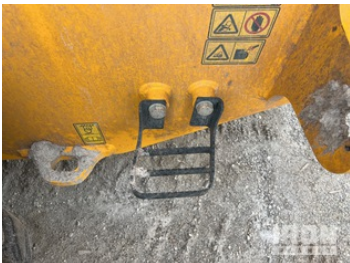
Steps	Left rear right rear steps damaged

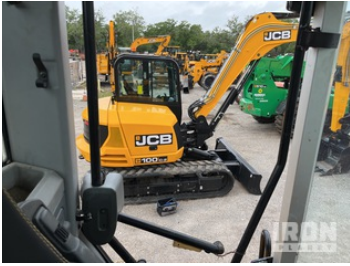
Glass	Left cab door shattered

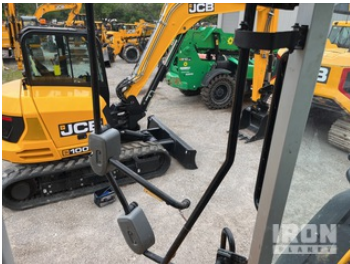
Cab Doors	Left door frame damaged

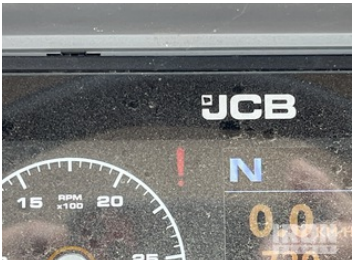
<p>Warning Lights</p>	<p>Operational, "!" Light in</p>

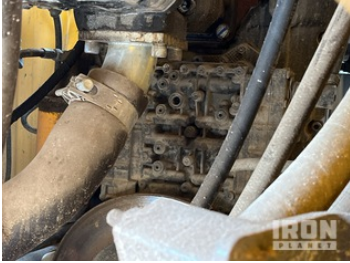
<b>Drivetrain</b>		
<b>Item</b>	<b>Assessment</b>	<b>Photo</b>
Transmission	★★☆☆ Operational

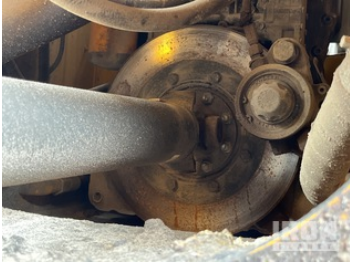
Transfer Case / Drop Box	★★☆☆ Operational

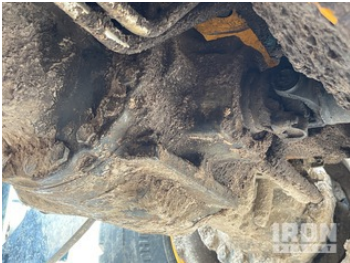
Front Drive Axle	★★☆☆

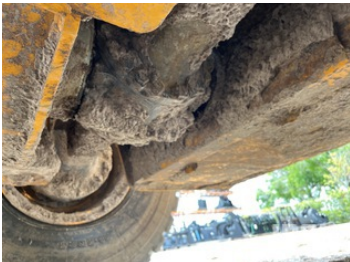
Rear Drive Axle	★★☆☆

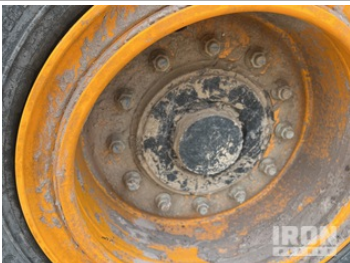
Final Drives	★★☆☆

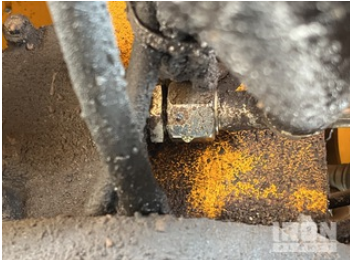
Hoses (Hydraulics)	★★★☆☆ Dripping leak hose fitting at valve body

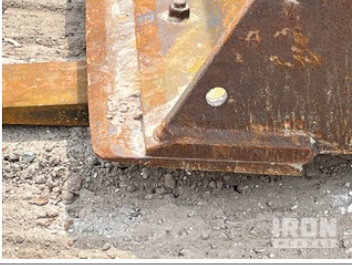
Loader Bucket Cutting Edge	★★☆☆☆ Edge worn Not turned
