## Item #13177108 - 2021 Volvo EC750E Tracked Excavator

# Inspection Report

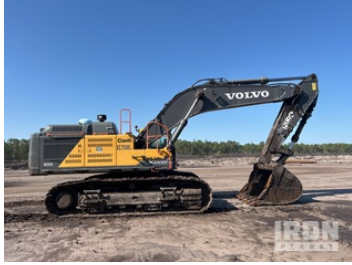
| Paint | Damage | |

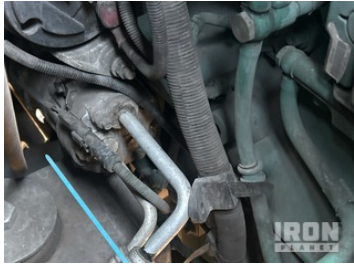
| Engine | | |
|---|---|---|
| A/C Compressor | In place; ambient temperature too cold to check operation | A photograph of the A/C compressor on the engine. The compressor is a cylindrical component with various hoses and wires connected to it. The word 'IRON' is visible in the bottom right corner of the photo. |

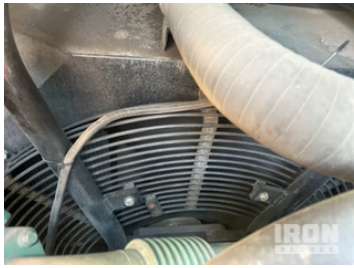
| Engine | | |
|---|---|---|
| Radiator | ★★★★☆ | A photograph of the radiator, showing the cooling fins and hoses. The word 'IRON' is visible in the bottom right corner of the photo. |

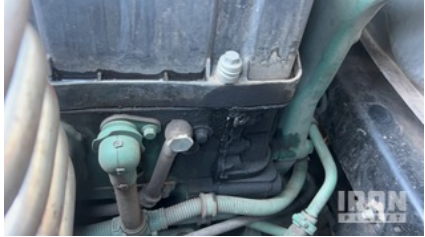
| Engine | | |
|---|---|---|
| Oil Leaks | Wiring harness input area | A photograph of the wiring harness input area, showing various electrical components and hoses. The word 'IRON' is visible in the bottom right corner of the photo. |

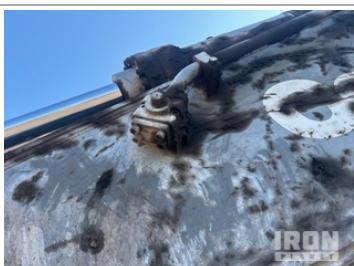
| Item | Assessment | Photo |
|---|---|---|
| Auxiliary Hydraulic Plumbing | Capped off, Not operationally checked, End of stick | |

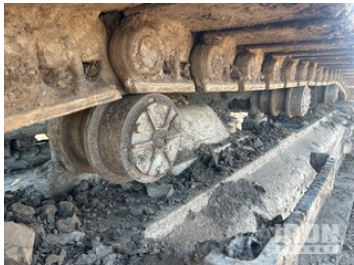
| Left Carrier Rollers | 3 carrier rollers #1 196 mm #2 198 mm #3 196 mm | |

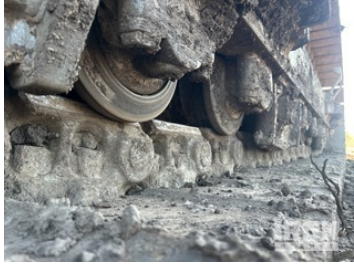
| Left Bottom Rollers | 8 Bottom Rollers #1 234 mm #2 236 mm #3 Guard mm #4 235 mm #5 236 mm #6 236 mm #7 Guard mm #8 234 mm | |

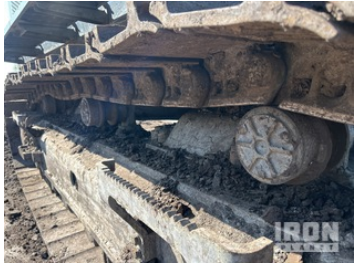
| Right Carrier Rollers | 3 Carrier Rollers #1 196 mm #2 197 mm #3 196 mm | |

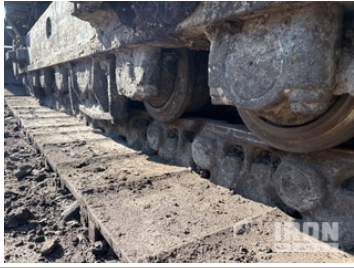
| Right Bottom Rollers | 8 Bottom Rollers: #1 235 mm #2 236 mm #3 Guard mm #4 235 mm #5 236 mm #6 236 mm #7 Guard mm #8 233 mm | |
