Item #12781136 - 2022 Astec Ranger I32 OC Tracked Impact Crusher Plant

Inspection Report

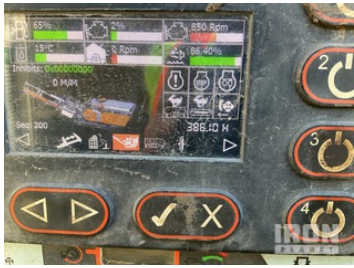
Hour Meter / Odometer	386 hrs

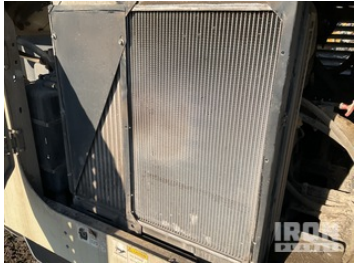
Radiator	★★☆☆ Some fins damaged

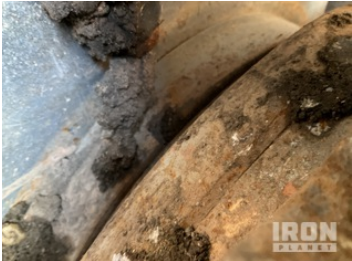
Power Travel Drive System	★★★★☆ 1 Travel Speed, Travels properly

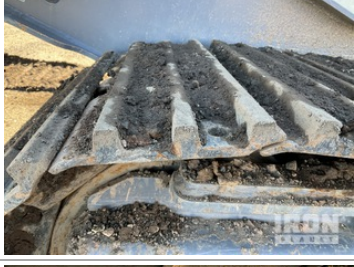
Left Grouser Height	19 mm

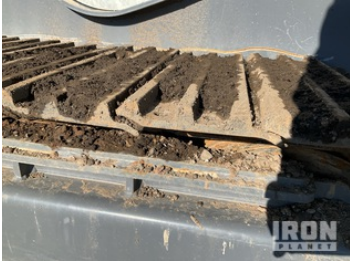
Right Grouser Height	18 mm
