## Item #12840166 - 2021 Astec GT125 Tracked Crushing Plant

# Inspection Report

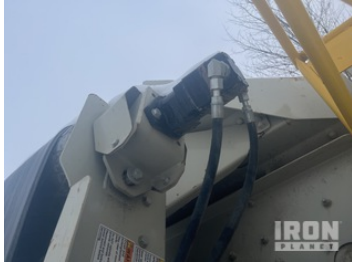
Hydraulic Motors	Not operationally checked, Conveyor motors engaged briefly, appear to be frozen due to snow and ice

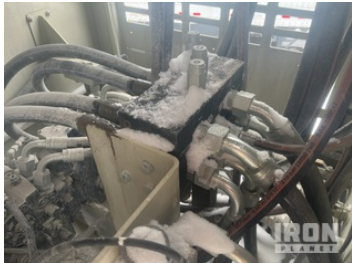
Valves	★★★☆☆ Dripping leak

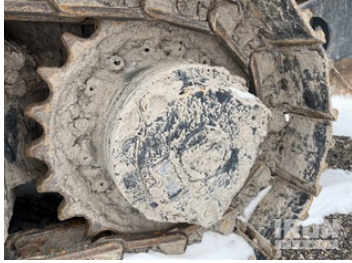
Power Travel Drive System	★★★★☆ Boggs when steering

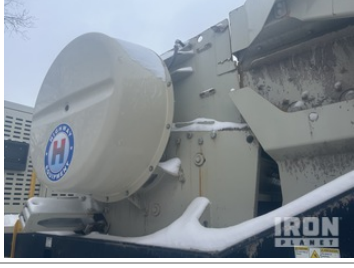
Crusher Chamber Frame	<p>★★★☆☆ Missing some bolts mounting chamber to frame</p>
