Item #5657167 - Claas 380RC Variant Round Baler

Inspection Report

General Appearance		
Item	Assessment	Photo
Serial Number / VIN	75204464

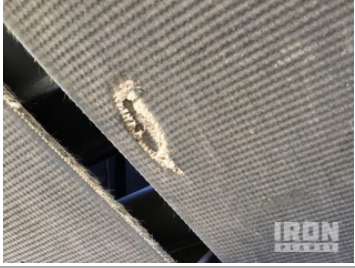
Roller Condition	★★☆☆ Dent damaged and missing support bracket components. See additional photos.	
Belt Condition (Implement)	★★☆☆ Wear damage visible on (1) belt

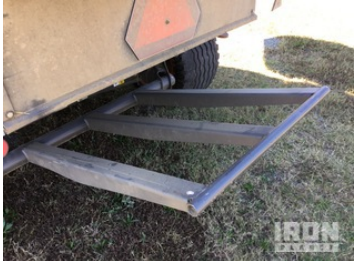
Bale Chamber	★★★★☆	
Bale Push Bar	★★★★☆

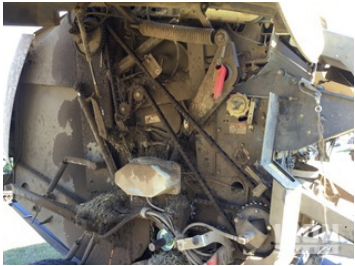
Drive Chains/Sprockets	★★★★☆

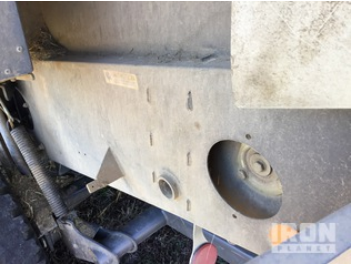
<p>Frame Rails/ Main Beams Condition</p>	<p>★★★★☆ No visible damage</p>

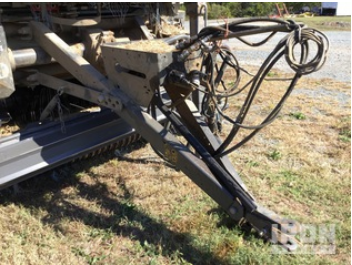
<p>Tongue/ Hitch Condition</p>	<p>★★★★☆ No visible damage</p>

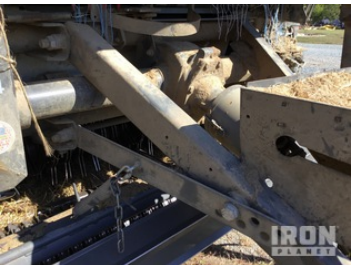
<p>Channel Supports</p>	<p>★★★★☆</p>

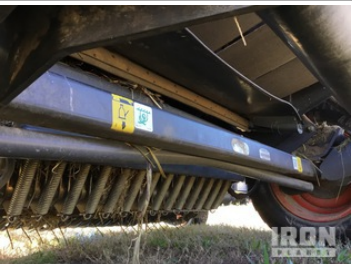
<p>Axle Condition</p>	<p>★★★★☆</p>

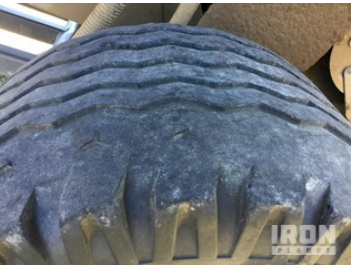
Tread Depth (4 tires)	LR 10 mm, RR 10 mm

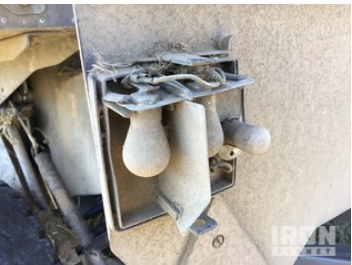
Wheel Condition	<p>★☆☆☆ Right front wheel bend damage at bead edge, that does not hold air pressure</p>	
Wheel Studs	<p>★★★★☆</p>	
Trailer Lights	<p>★★☆☆☆ Not operationally checked, Left side taillight housing damaged, Right side taillight mount crack damage</p>
