Item #14698438 - Kobelco SK210LC-11 Tracked Excavator

Inspection Report

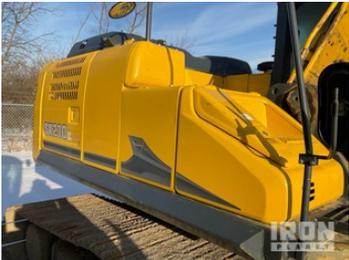
| Paint | No visible damage | |

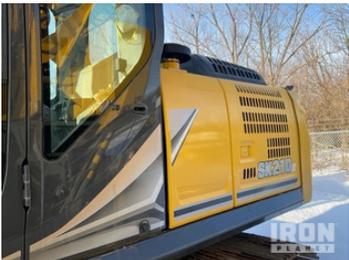
| Body Panels | No visible damage or missing components | |

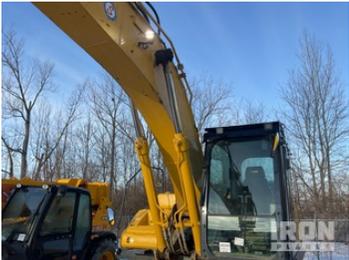
| Exterior Lights | 2 Inoperable / damaged / missing | |

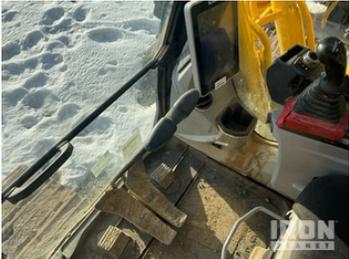
| Steering Controls | ★★★★☆ | |

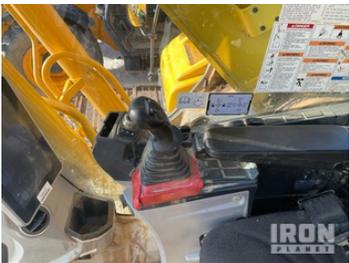
| Hydraulic Controls | ★★★★☆ | |

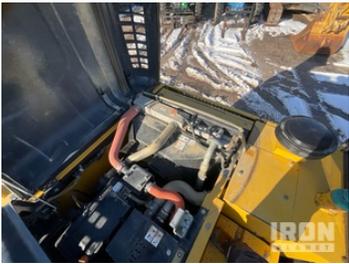
| Item | Assessment | Photo |
|---|---|--|
| Radiator | ★★★★☆ | |

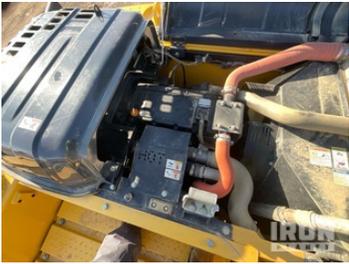
| Item | Assessment | Photo |
|---|---|--|
| Oil Leaks | No dripping leaks | |

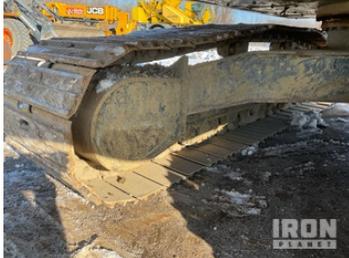
| Item | Assessment | Photo |
|---|---|--|
| Left Drive Motor | ★★★★☆ | |

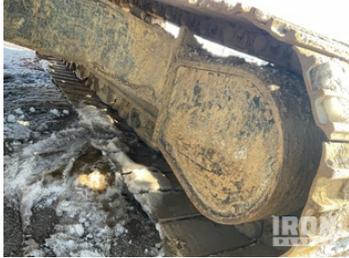
| Item | Assessment | Photo |
|---|---|--|
| Right Drive Motor | ★★★★☆ | |

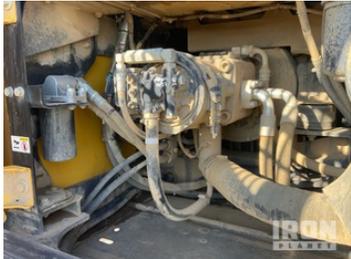
| Item | Assessment | Photo |
|---|---|--|
| Pumps (Hydraulics) | ★★★★☆ | |

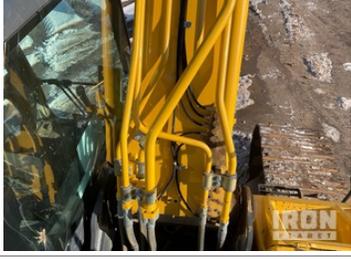
| Item | Assessment | Photo |
|---|---|--|
| Hoses (Hydraulics) | ★★★★☆ | |

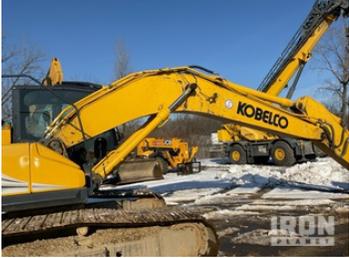
| Item | Assessment | Photo |
|---|--|--|
| Boom Condition | ★★★★☆ | |

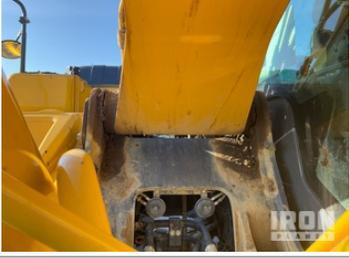
| Item | Assessment | Photo |
|---|--|--|
| Boom Base Pin and Bushings | ★★★★☆ | |

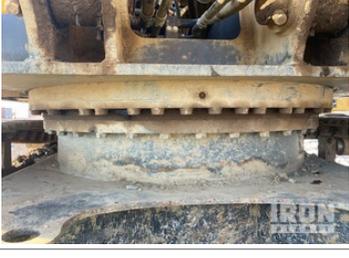
| Item | Assessment | Photo |
|---|--|--|
| Turntable Bearing | ★★★★☆ | |

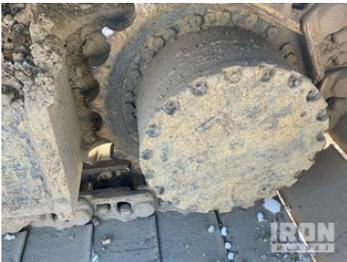
| Left Sprocket | ★★★★☆ | |

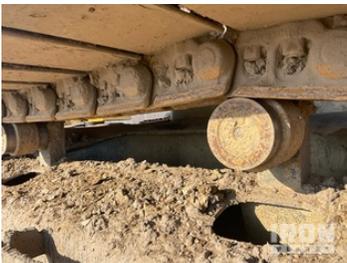
| Right Track Links | 101 mm | |

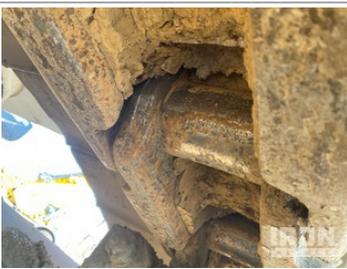
| Right Track Bushings | 50 mm | |

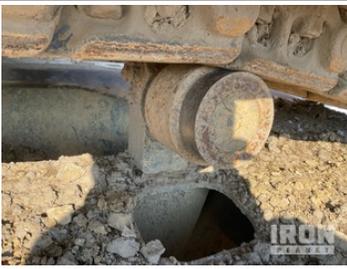
| Right Carrier Rollers | 2 Carrier Rollers #1 120 mm #2 120 mm | |

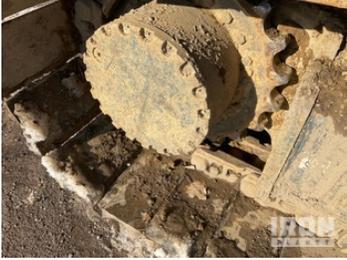
| Right Sprocket | ★★★★☆ | |

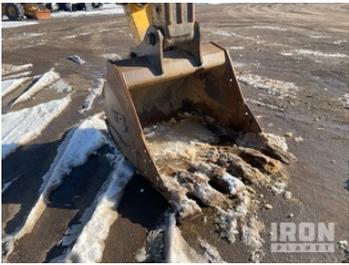
| Item | Assessment | Photo |
|---|---|---|
| Excavator Bucket Condition | ★★★★☆ | A close-up photograph of an excavator bucket filled with dirt and debris. The bucket is yellow and has a black hydraulic cylinder. The background shows a dirt surface. An "IRON PLANET" logo is visible in the bottom right corner of the photo. |
