## Item #14954803 - 2021 Gradall XL4100V Highway Wheeled Excavator

# Inspection Report

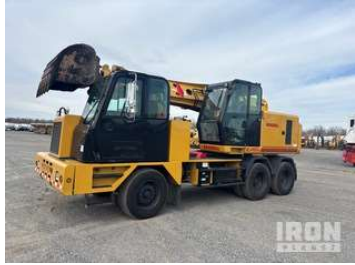
| Paint | Asphalt residue, On boom and bucket | |

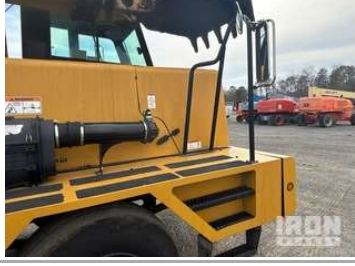
| Hand Rails | Cab entry hand rail bent, Road cab entry has signs of weld repair | |

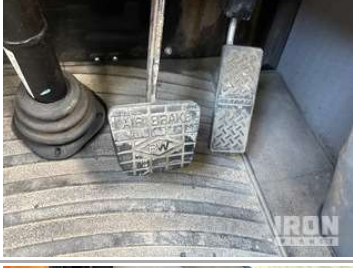
| Drivetrain Controls | ★★★★☆<br>Could not engage upper cab drivetrain controls. | |

| Item | Assessment | Photo |
|---|---|---|
| Limited Function Check | The drivetrain was operational as noted., Upper cab drivetrain cannot be engaged. | |

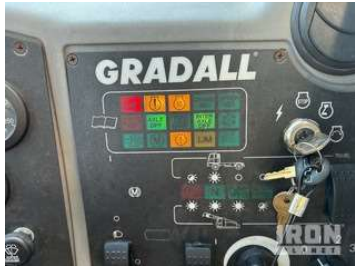
| Warning Lights | Operational, Check engine light stays on | |

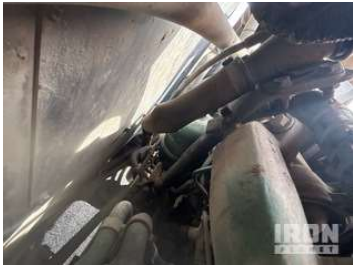
| Oil Leaks | Oil fill tube. | |

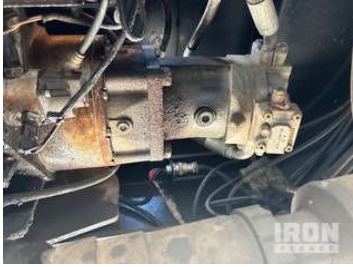
| Item | Assessment | Photo |
|---|---|---|
| Pumps (Hydraulics) | ★★☆☆<br>Dripping leak | |

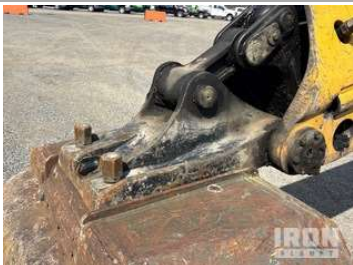
| Specialty | | |
|---|---|---|
| Quick Coupler | ★★★★☆<br>Not operationally checked | |
