Item #12781173 - 2022 Astec GT125 Tracked Jaw Crushing Plant

Inspection Report

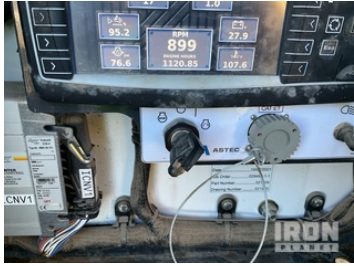
Engine Controls	★★★★☆

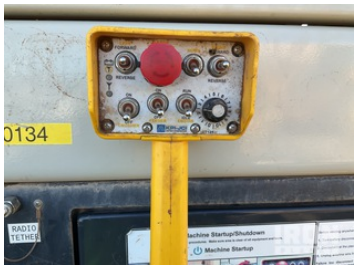
Crusher/Screen Controls	★★★★☆

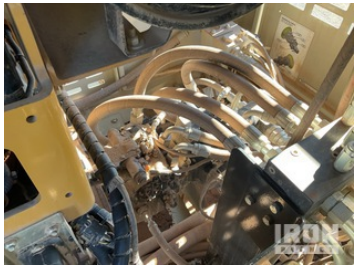
Hydraulics		
See photos for condition		
Item	Assessment	Photo
Pumps (Hydraulics)	★★★★☆

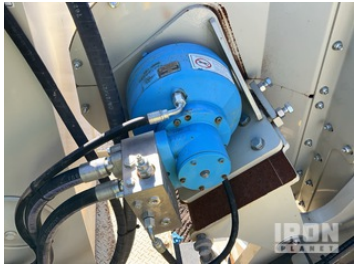
Hydraulic Motors	★★★★☆

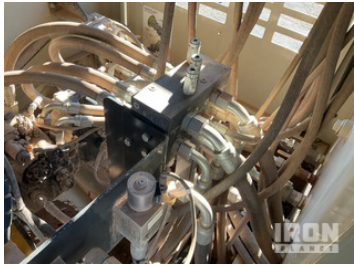
Valves	★★★★☆

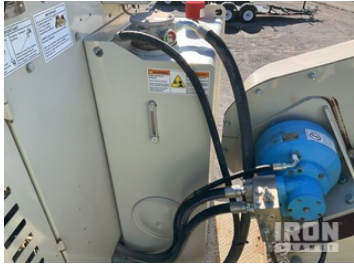
Hydraulic Tank	★★★★☆

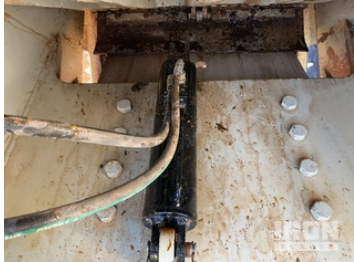
Crusher Door Cylinders	★★★★☆

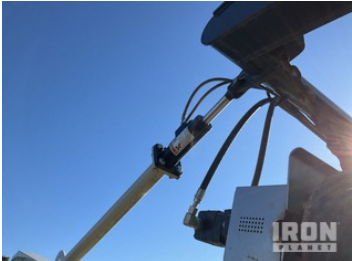
Conveyor Cylinders	★★★★☆

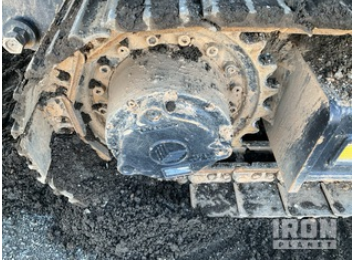
Power Travel Drive System	★★★★☆ 1 Travel Speed

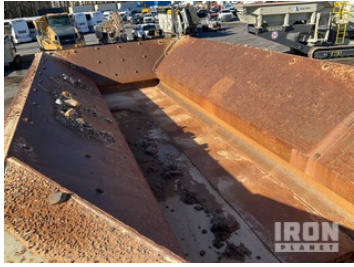
Chassis		
Item	Assessment	Photo
Feed Hopper	★★☆☆ Length @ top: 12'8", Width @ top: 6'10"

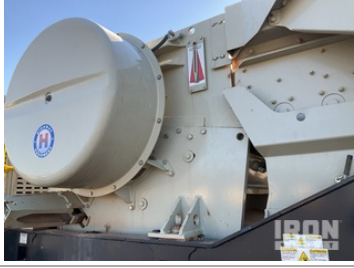
Crusher Base Frame	★★☆☆

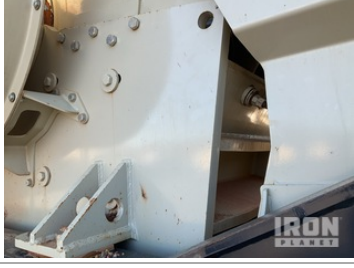
Crusher Chamber Frame	★★☆☆

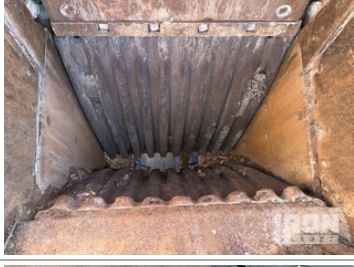
Jaw, Blow Bar and Anvil Wear Surface	★★☆☆ Jaw width and spacing between jaws 24"

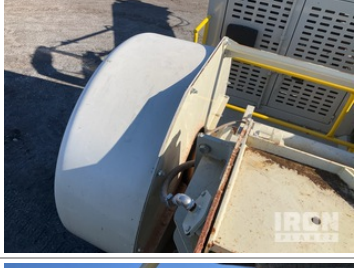
Crusher Drive System	★★☆☆

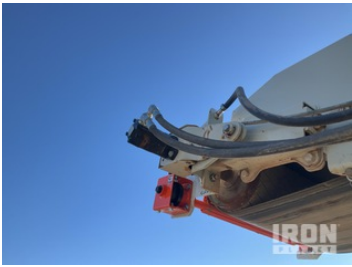
<p>Discharge Conveyor Drive Motor</p>	<p>★★★★☆ Operational</p>

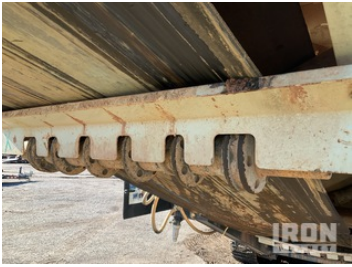
<p>Discharge Conveyor Rollers</p>	<p>★★★★☆</p>

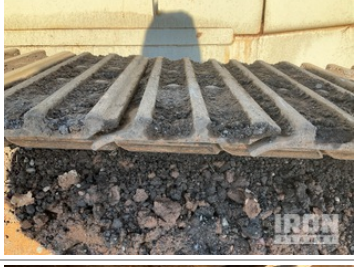
Left Grouser Height	19 mm

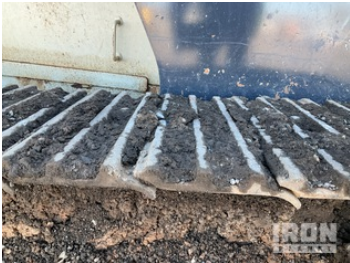
Right Grouser Height	19 mm

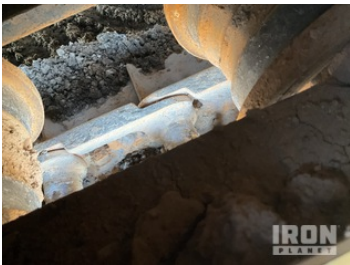
Right Track Bushings	Bushings have not been turned
