## Item #9801441 - 2019 Wacker Neuson WL38 Wheel Loader

- Features: Enclosed Cab, Air Conditioner, Hydraulic Coupler, 72 in
- Meter Reading: 854 Hours
- Serial # : 3046489
- Inspection Completed: 5/3/23

# Inspection Report

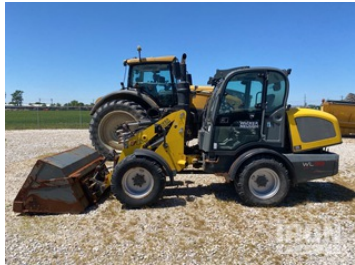
| Item | Assessment | Photo |
|---|---|---|
| Paint | feed lot corrosion | |

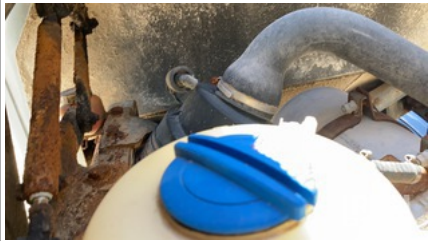
| <b>Engine</b> | | |
|---|---|---|
| Limited Function Check | There was no response from the engine when the key was turned. Hood hinges are corroded and will not articulate completely open | |

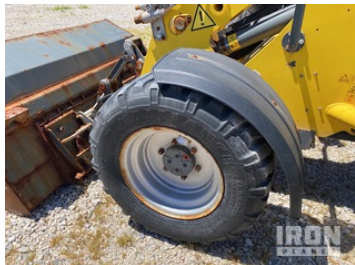
| Item | Assessment | Photo |
|---|---|---|
| Left Front Tire | ★★★★☆<br>Alliance 385/55R18 30/32" Tread Depth | |

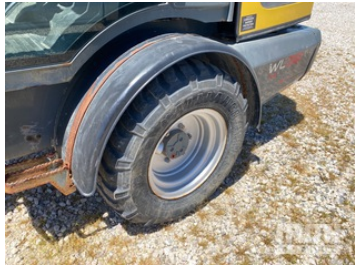
| Item | Assessment | Photo |
|---|---|---|
| Left Rear Tire | ★★★★☆<br>Alliance 385/55R18 28/32" Tread Depth | |

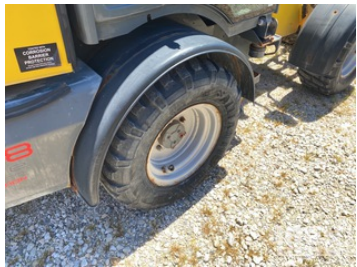
| Right Rear Tire | ★★★★☆<br>Alliance 385/55R18 28/32" Tread Depth | |

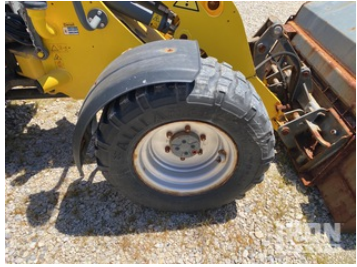
| Right Front Tire | ★★★★☆<br>Alliance 385/55R18 30/32" Tread Depth | |

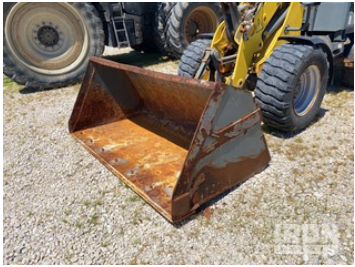
| Wheel Loader* | | |
|---|---|---|
| Loader Bucket Condition | ★★☆☆☆<br>Corrosion | |

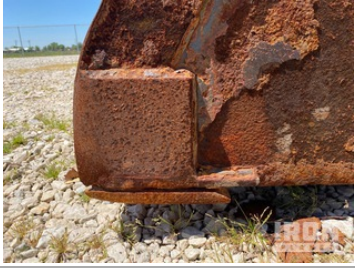
| Wheel Loader* | | |
|---|---|---|
| Loader Bucket Cutting Edge | ★★☆☆☆<br>Edge worn | |

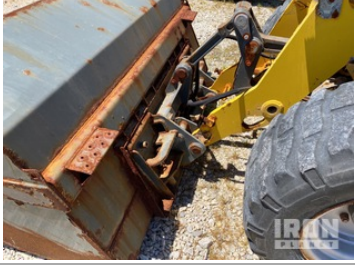
| Wheel Loader* | | |
|---|---|---|
| Loader Quick Coupler | ★★☆☆☆<br>Not operationally checked | |
