Item #11535314 - JCB 220XL 4F Tracked Excavator

Inspection Report

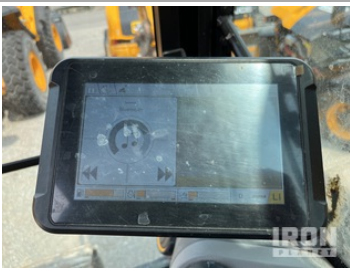
Engine Oil Pressure	No oil pressure indicator	
Warning Lights	Operational

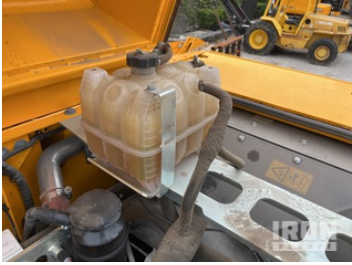
Radiator	☆☆☆☆

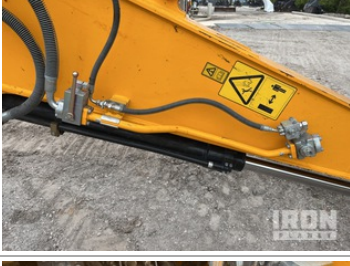
Auxiliary Hydraulic Plumbing	Not operationally checked, End of stick

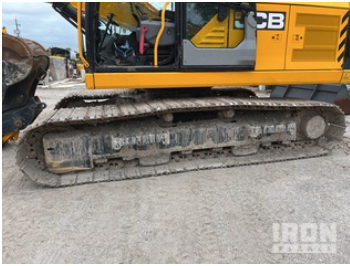
Undercarriage		
Undercarriage components photos (links, bushings, sprockets, idlers, rollers, grousers) are selected as representative. Bidders are encouraged to review photos using the zoom feature to judge condition in detail.		
Item	Assessment	Photo
Track Link Brand	No mark	
Left Roller Frame	★★★☆☆

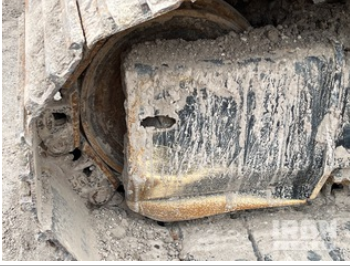
Left Track Tensioner	★★★☆☆

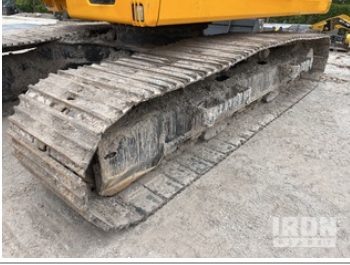
Left Track Pads	★★★☆☆ 31.6 in Wide Triple Grouser

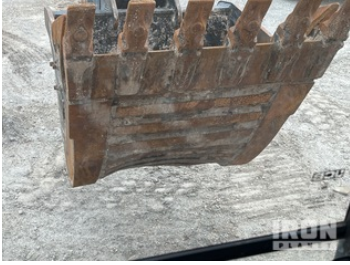
Specialty		
Item	Assessment	Photo
Excavator Bucket Condition	★★☆☆ Bottom of bucket pushed in

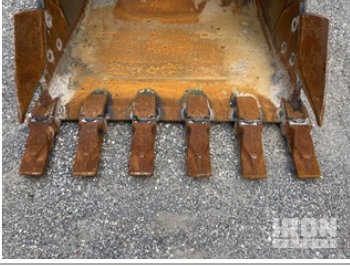
Bucket Cutting Edge/Shanks/Teeth	★★★☆ No visible damage or missing components

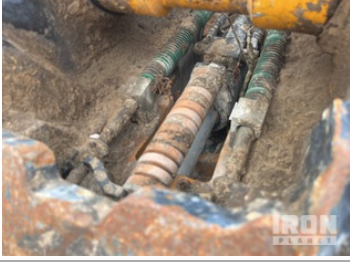
Quick Coupler	★★★☆ Operational
