Item #12781132 - 2023 Astec Ranger SRT11 Tracked Screen Plant

Inspection Report

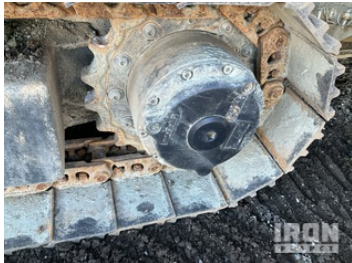
Power Travel Drive System	★★☆☆☆ 1 Travel Speed, Feels weak

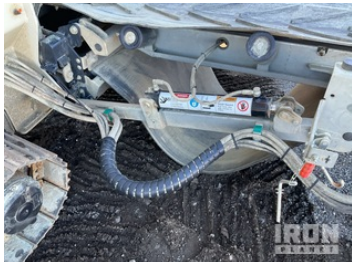
Limited Function Check	The hydraulic system was operational. Left Discharge Conveyor doesn't operate, belt is super loose and off track.	
Hydraulics #1

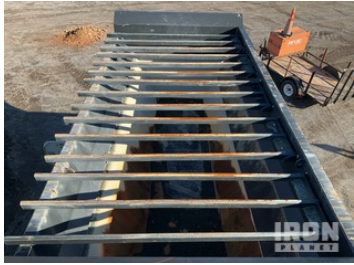
Chassis		
Item	Assessment	Photo
Feed Hopper	★★☆☆☆ Length @ top: 13 ft 4 in, Width @ top: 5 ft 9 in, Width between grizzly bars: 8 in

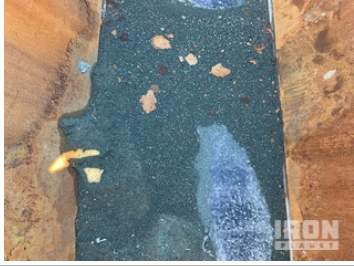
Feed Conveyor Condition	★★☆☆☆ 30 in wide feed belt

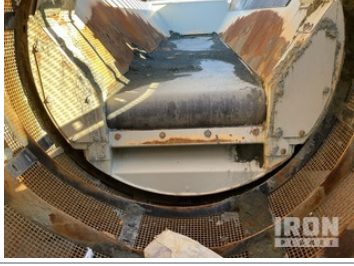
Feed Conveyor Frame	★★☆☆☆

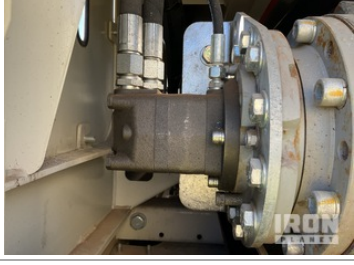
Feed Conveyor Drive Motor	★★☆☆☆ Operational

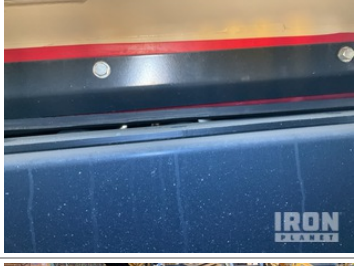
Feed Conveyor Rollers	★★☆☆☆

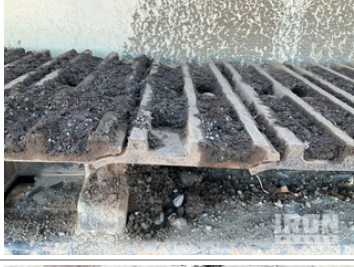
Left Grouser Height	18 mm

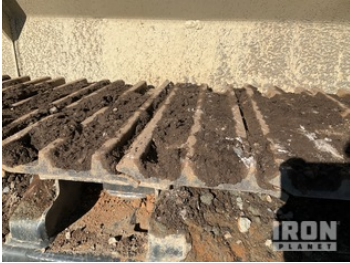
Right Grouser Height	18 mm
