Item #12781135 - 2023 Screen Machine 612T Tracked Screen Plant

Inspection Report

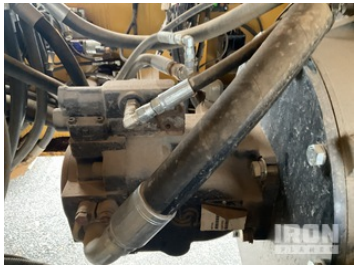
Hydraulics		
See photos for condition		
Item	Assessment	Photo
Pumps (Hydraulics)	★★★☆☆

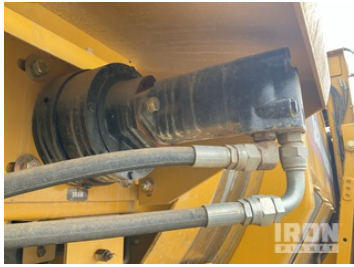
Hydraulic Motors	★★★☆☆

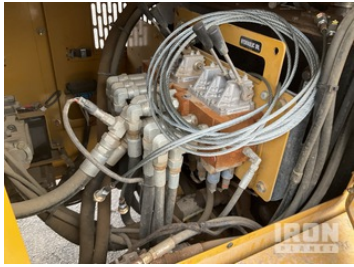
Valves	★★★☆☆

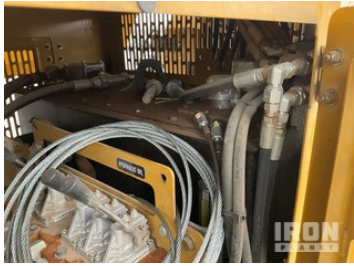
Hydraulic Tank	★★★☆☆

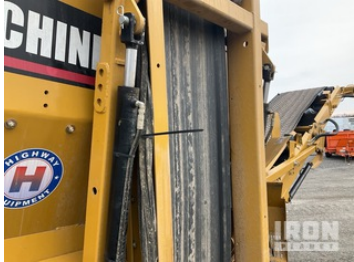
Conveyor Cylinders	★★☆☆☆ Inoperable

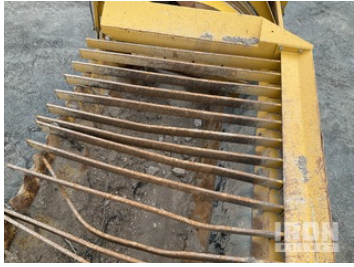
Chassis		
Item	Assessment	Photo
Feed Hopper	★★☆☆☆ Length @ top: 9 ft, Width @ top: 6 ft, Grizzly length: 9 ft, Width between grizzly bars: 6 in, Grizzled bars are bent

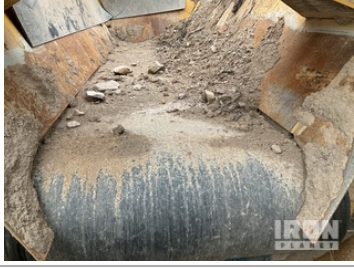
Feed Conveyor Condition	★★★☆☆ 36 in wide feed belt

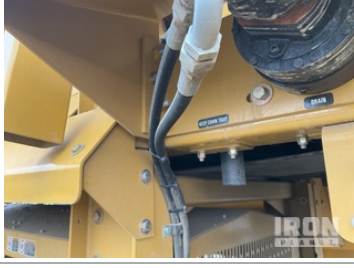
Feed Conveyor Frame	★★★☆☆

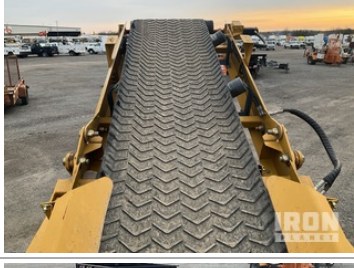
Discharge Conveyor Condition	★★☆☆☆ Worn, not centered

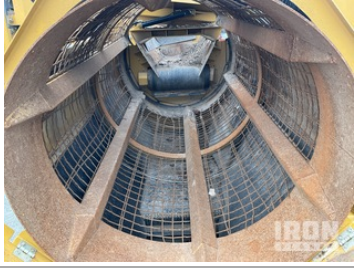
Screen Deck	★★☆☆☆ Screen damaged

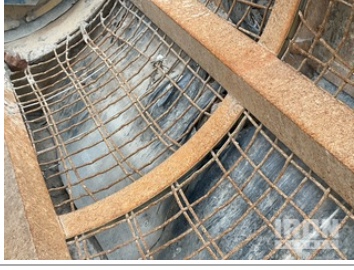
Screen Cloth	★★☆☆☆ Heavy wear
