## Item #12781134 - 2023 Screen Machine 514TS Tracked Screen Plant

# Inspection Report

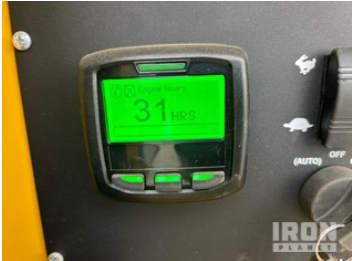
Hour Meter / Odometer	31 hrs

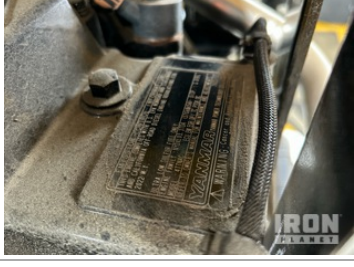
Emission Certification Label	US EPA certification label

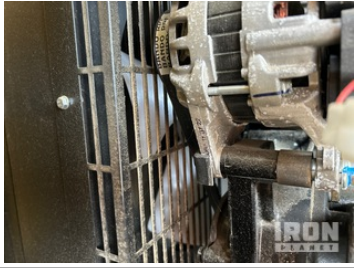
Radiator	★★★★

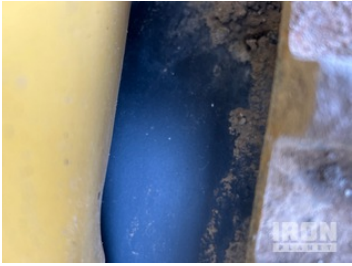
Power Travel Drive System	★★★★☆ 2 Travel Speeds, Travels properly

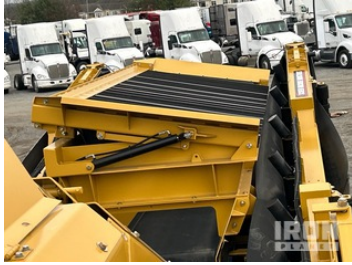
Feed Hopper	Grizzly length: 14'7"

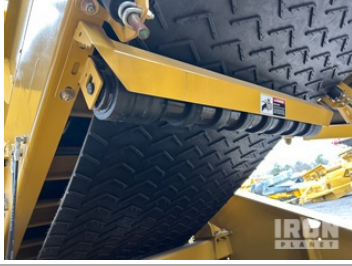
Feed Conveyor Condition	★★★★★ 42 in wide feed belt

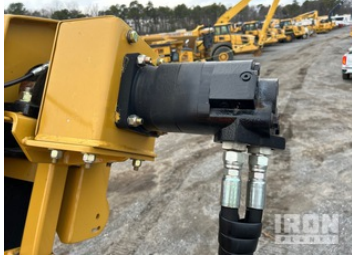
Discharge Conveyor Drive Motor	Not operationally checked

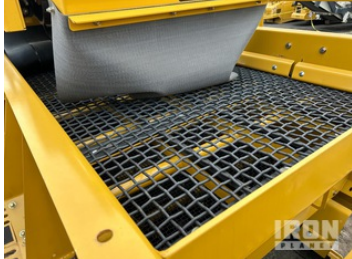
Screen Deck	★★★★★ Flat screen

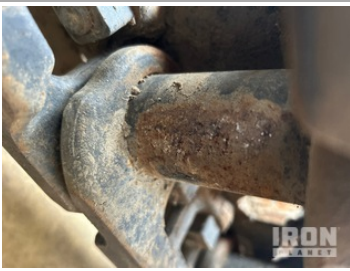
Left Track Bushings	Bushings have not been turned
