Item #11535316 - JCB 220XL 4F Tracked Excavator

Inspection Report

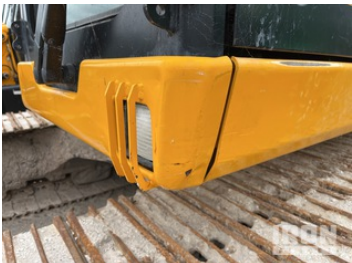
Body Panels	Left Side Cover damaged, Left front lower cab corner panel damaged. Right side rail damaged.

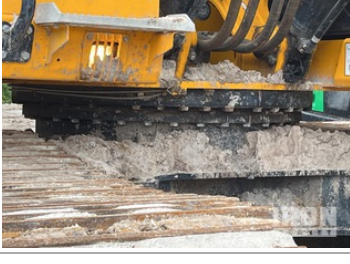
Bottom Covers	2 Damaged	
Limited Function Check	The main components were operational in a limited check.

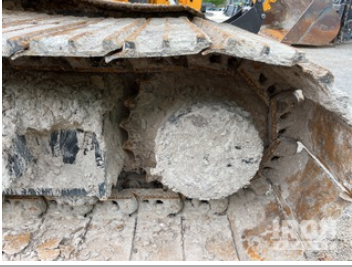
Left Sprocket	★★☆☆ good

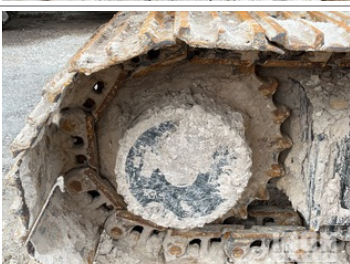
Right Sprocket	☆☆☆☆ Wear

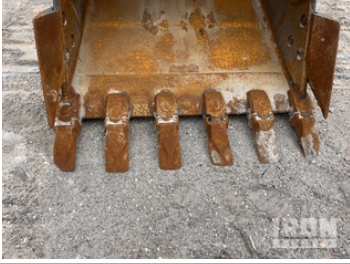
Bucket Cutting Edge/Shanks/Teeth	★★☆☆☆ Wear
