Job #: 30624 /

Serial #: 942451

BROKK 160 ROBOT W/ ATLAS COPCO
BREAKER / CC520 CONCRETE CRUSHER

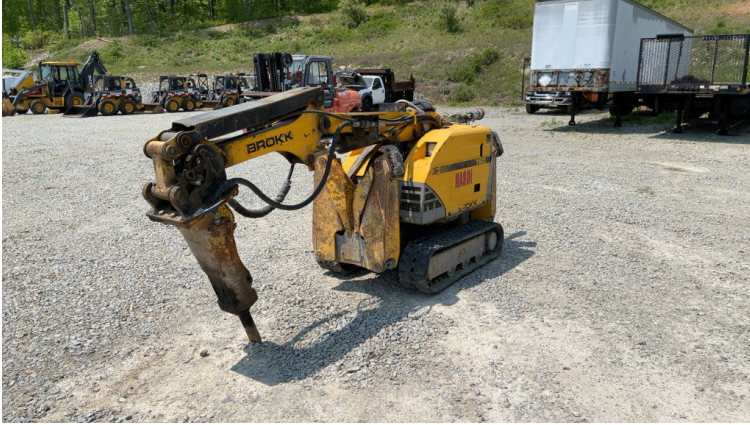
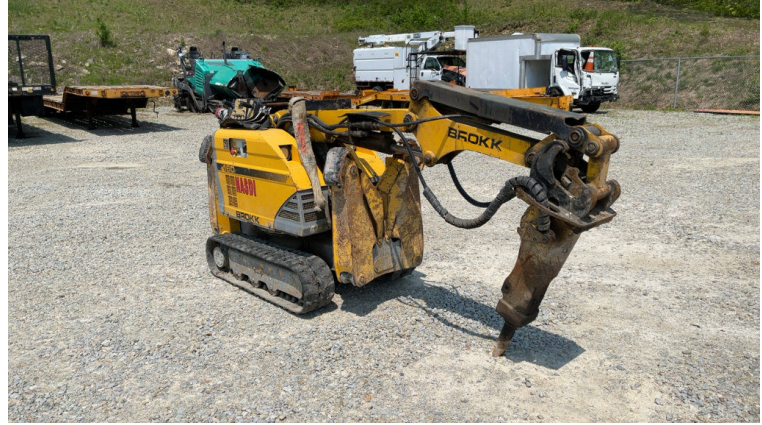
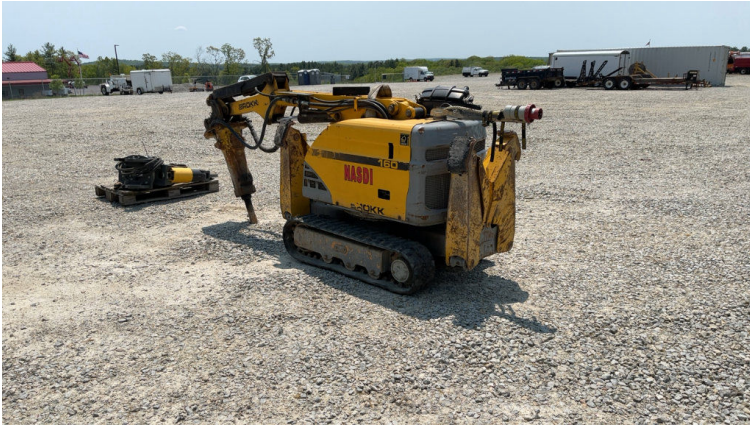
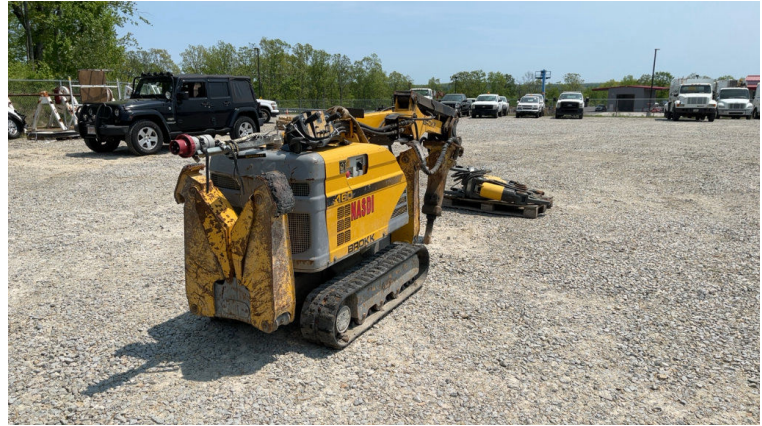
Inspection Details	
Year	Not Available
Make	Brokk
Model	160 Robot
Serial Number	942451 - See Notes
Type	Remote Control Demolition Machine
Date Of Inspection	5/19/2021
Location of Inspection	JJ Kane Auctioneers; 11 Fortune Blvd, Shrewsbury, MA 01545
Attachment(s)/ Accessory(s)	Atlas Copco Breaker and Darda CC520 Concrete Crusher Serial Number 305
Hours	Not Available
Operations Test	NA
Enclosed Cab	NA
Boom Arm	Good Condition
Boom Arm Operations	NA
Lift Cylinder	Good Condition
Left Track Condition	Gouge

Inspection Details Cont'd	
Left Track Brand	Not Available
Left Track Tread Depth Measurement	10/32"
Left Track Tread Depth Percentage	Above 50%
Right Track Condition	Gouge
Right Track Brand	Not Available
Right Track Tread Depth Measurement	8/32"
Right Track Tread Depth Percentage	Under 50%
Front Left Stabilizer Pad	Worn Out
Front Right Stabilizer Pad	Worn Out
Back Left Stabilizer Pad	Worn Out
Back Right Stabilizer Pad	Worn Out
Engine Door	Unable to Open
Engine Compartment	Not Accessible
Engine MFR	Not Available
Working Lights	NA
Hydraulic Lines	Good Condition - No Leaks
Left Track Sprocket	Good Condition
Left Track Rollers	Good Condition
Left Track Idler	Good Condition
Right Track Sprocket	Good Condition
Right Track Roller	Good Condition
Right Track Idler	Good Condition
Customer Decal Visible on Unit	Yes
Comments	This machine requires a generator and specific power lines in order to operate that the site location doesn't have. Due to this, we are unable to confirm the regular operations of the machine. The serial number plate could not be located on the machine to verify the serial number. The site confirmed that this was the correct unit. Due to the placement of the stabilizer cylinders, we were unable to open the engine door to access the engine compartment.
