Aspen Field Services

Job #: 24405 / Serial #: H2430055

Inspection Details		
Master Lease Number	001-0436024-107	
Year	2017	
Make	Hamm	
Model	HD120i VV HF	
Serial Number	H2430055	
Туре	Roller	
Inspection Date	9/16/2020	
Location of Business	JJ Kane Auctioneers - 95 3rd St N , Graysville, AL 35073, USA	
Attachment(s)	None	
Enclosed Cab	No	
Engine MFR	Deutz	
Controls	Standard	
Cab A-C	None	
Cab Heat	None	
Deluxe Instrumentation	None

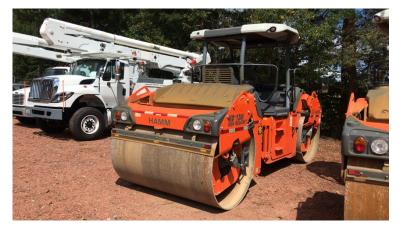
Inspection Details Cont'd		
Keyless Start	No	
Visual Inspection	Clean	
Operations Test	Pass	
Front Roller Condition	Good Condition	
Front Roller Thickness	3/4"	
Front Roller Diameter	54"	
Front Roller Width	78"	
Rear Roller Condition	Good Condition	
Rear Roller Thickness	3/4"	
Rear Roller Diameter	53"	
Rear Roller Width	78"	
Front and Rear Depth Percentage	Above 50%	
Seat	Good Condition	
Tailgate Lights	Non Operational	
Working Lights	Good Condition	
ROPS Condition	Good	
Engine Door	Good Condition	
Intake Screen	Good Condition	
Articulating Cylinder	Good Condition	
Interior Condition	Good	
Engine Compartment	Clean	
Customer Decals Visible on Unit	None	
Hours	2574	
Comments	The working lights and tailgate lights are non operational.
