BOBCAT EQUIPMENT CONDITION REPORT

Make:	Bobcat	Type:	Skid Steer	Inspector:	RC
Model:	S66	Hours:	1802	Inspection Date:	1/3/2025
SN:	B4SA14078	Year:	2022

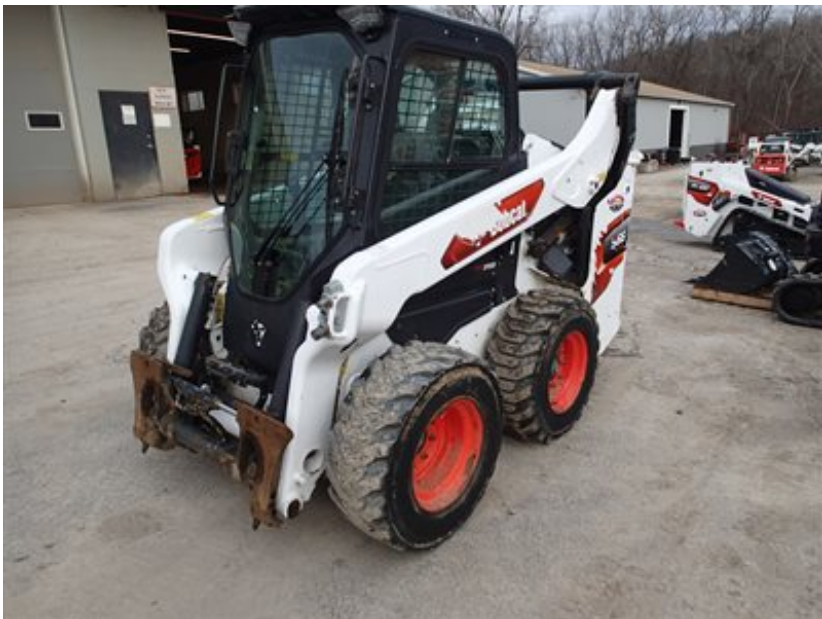
FRONT AXLE		
Make: GALAXY Part #: 002681 Measure: 0 / 32 Condition: POOR Tread Remaining: Under 50% Fault:		Make: ASCENSO Part #: SSB331 Measure: 17 / 32 Condition: GOOD Tread Remaining: Over 50% Fault:

Check	Comments / Deficiencies
✓ Visual Inspection	CLEAN
✓ Operational Test	PASSED - MOVED FORWARD/BACK WARD - LIFTED UP AND DOWN
✓ Lift Cylinders	NO LEAKS
✓ Tilt Cylinders	NO LEAKS
✓ Boom Arms Operations	WORKING
✓ Seat	GOOD CONDITION
✓ Tailgate Lights	GOOD CONDITION
✓ Working Lights	GOOD CONDITION
✓ Front Door	NO DAMAGES
✓ Rear and Top Window	NO DAMAGES
✓ Side Glass Complete	NO DAMAGES
✓ Boom Arms Damages	NO DAMAGES
✓ Rear Door	OPENS AND CLOSES AND STAYS CLOSED
✓ Mufflers	GOOD CONDITION
✓ ROPS Condition	GOOD CONDITION
✓ Power Bob-Tach Condition	OPERATIONAL
✓ Cab A-C Condition	WORKING
✓ Cab Heat Condition	WORKING
✓ Intake Screen	GOOD CONDITION
✓ Eng. Compartment	
N/A Hydraulic X-Change Condition	
✓ Customer Decals Visible on Unit	NO
✓ Error Codes	
X Front Left Tire Depth Percentage	FRONT LEFT TIRE UNDER 50%

ROPS:	Yes	Hours:	1802			
Enclosed Cab:	Yes	Cab Heat:	Yes	Cab A/C:	Yes	Controls: Standard
Attachment on Machine:	N/A					
Additional Attachments:	N/A					
2-Speed:	Yes	Engine MFR:	BOBCAT	Tires		
High Flow Hydraulics - Sticker:	No	Power Bob-Tach:	Yes	Keyless Start:	Yes	
Backup Camera:	No	Ride Control:	Yes	Deluxe Instrumentation:	Yes	
Hydraulic X-Change:	No					
Comments and Defects:	RUNS GOOD,NO BUCKET, NEEDS LEFT FRONT TIRE,REASR DOOR DENTED, NEEDS DECALS,
