## Item #11535367 - JCB 427 ZX Wheel Loader

# Inspection Report

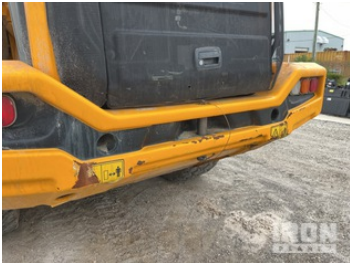
Paint	No visible damage

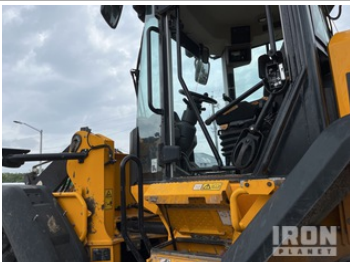
Hand Rails	No visible damage or missing components

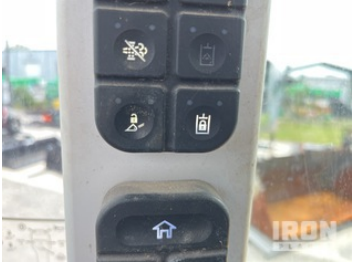
<b>Safety</b>		
<b>Item</b>	<b>Assessment</b>	<b>Photo</b>
Travel Alarm	Operational	
Horn	Operational	
Seat Belts	Operational	
Safety Lock Out/Stop	Operational

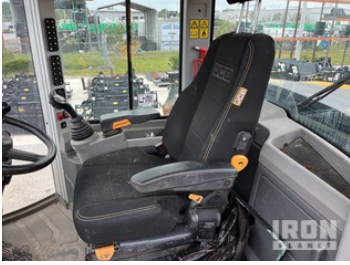
Control Station		
Item	Assessment	Photo
Seat/Armrests	No visible damage or missing components

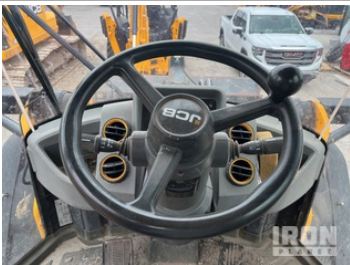
Steering Controls	★★★★☆

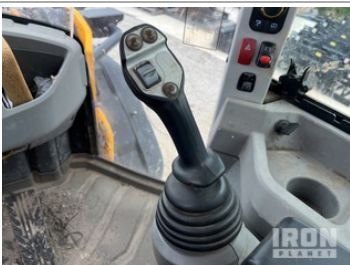
Hydraulic Controls	★★★★☆

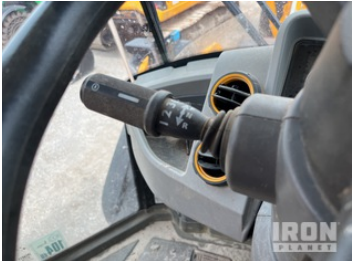
<p>Drivetrain Controls</p>	<p>★★★★☆</p>

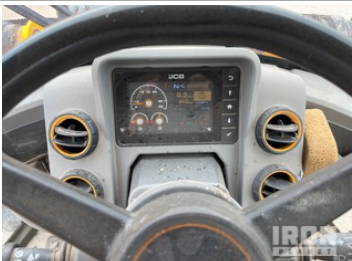
<p>Dash Console</p>	<p>★★★★☆</p>

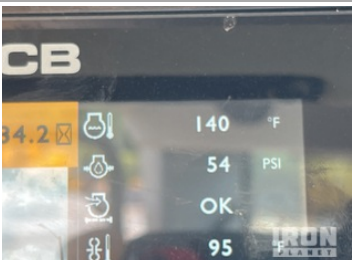
<p>Engine Oil Pressure</p>	<p>The gauge registers in the operating range.</p>

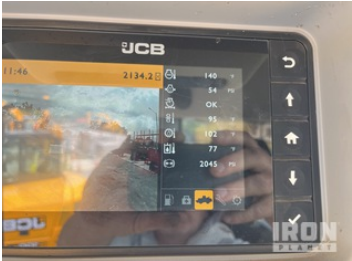
<p>Gauges</p>	<p>Operational</p>

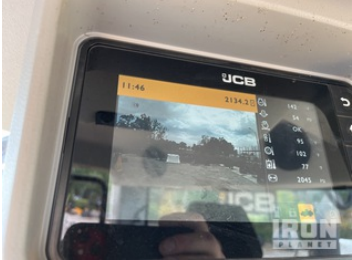
<p>Rear View Camera</p>	<p>Camera operates as intended</p>

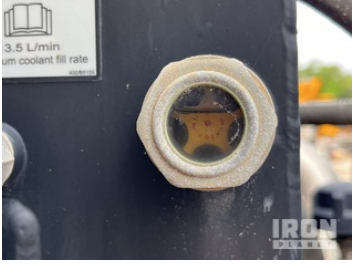
Radiator	★★★★☆

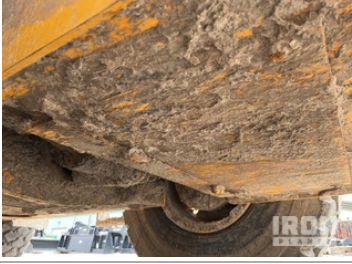
Oil Leaks	No dripping leaks

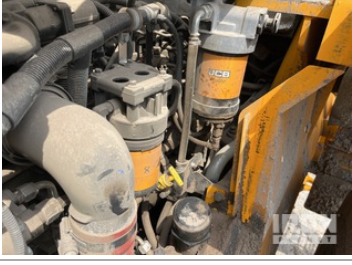
Fuel Leaks	No dripping leaks

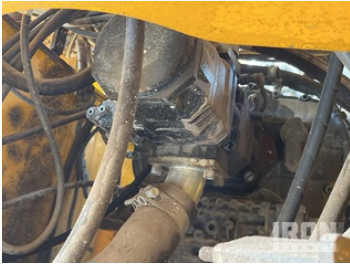
<b>Hydraulics</b>		
See photos for condition		
<b>Item</b>	<b>Assessment</b>	<b>Photo</b>
Pumps (Hydraulics)	★★★★☆

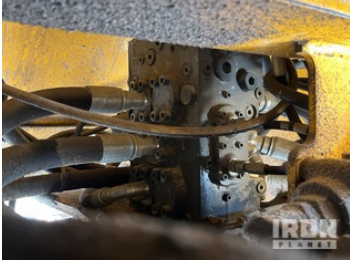
Valves	★★★★☆

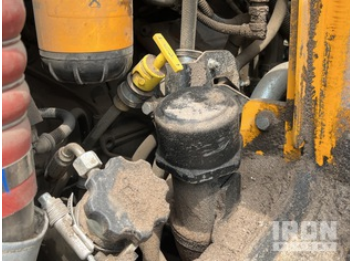
Hydraulic Tank	★★★★☆

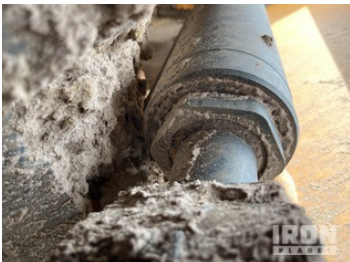
Loader Lift Cylinders	★★★★☆

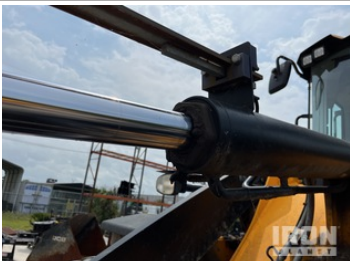
Bucket Tilt Cylinders	★★★★☆

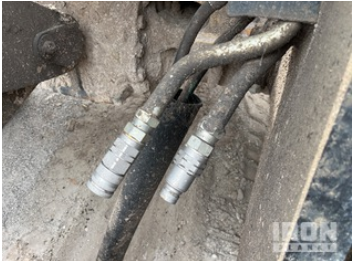
Auxiliary Hydraulic Plumbing	Not operationally checked, Front

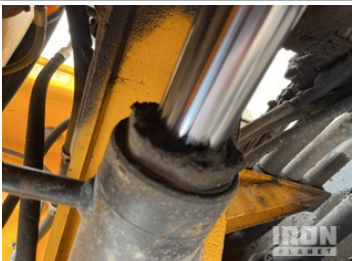
Steering Cylinders	★★★★☆

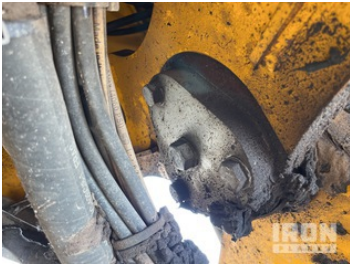
Chassis		
IronPlanet pin connection pivot point wear inspections are limited to sound, sight and feel observations. Dial indicator testing is not performed.		
Item	Assessment	Photo
Articulating Center Pins	★★★★☆

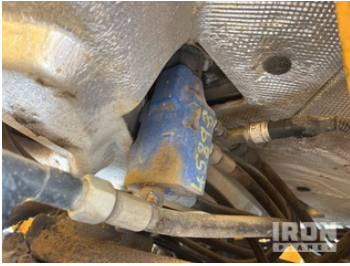
Brake Type	Hydrostatic	
Master Cylinder	★★★★☆

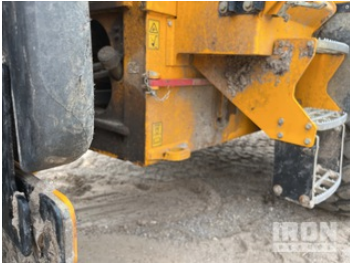
Brake Lines/Hoses	★★★★☆	
Park Brake	★★★★☆ Stopped from a slow roll	
Limited Function Check - Brakes	The brake system functioned, stopping and holding the machine.	
Frame Condition	★★★★☆

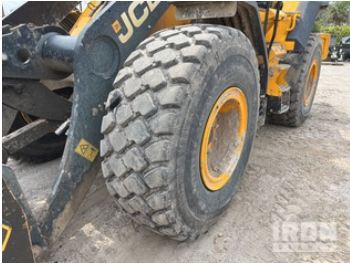
Left Front Tire	★★★★☆ JCB earthmover 20.5R25 32/32" Tread Depth

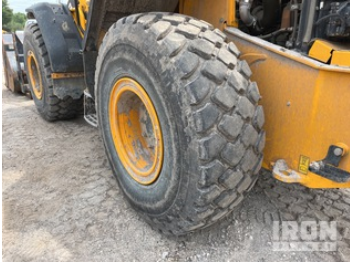
Left Rear Tire	★★★★☆ " " " 29/32" Tread Depth

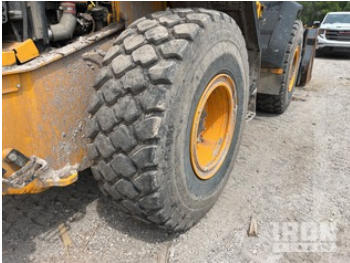
Right Rear Tire	★★★★☆ " " " 29/32" Tread Depth

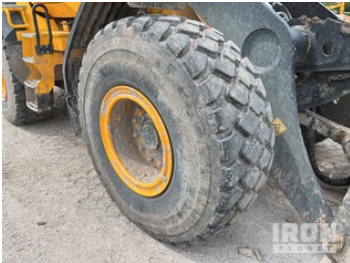
Right Front Tire	★★★★☆ " " " 32/32" Tread Depth

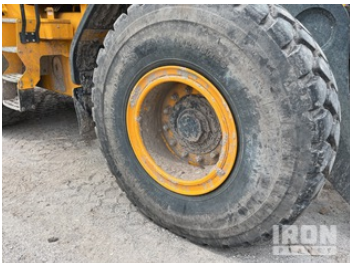
Wheel Condition	No visible damage or missing components

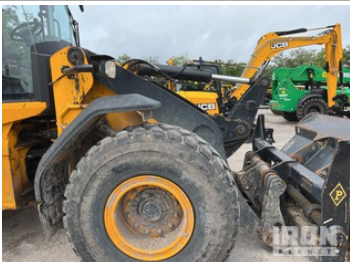
Lift Arm Condition	★★★★☆

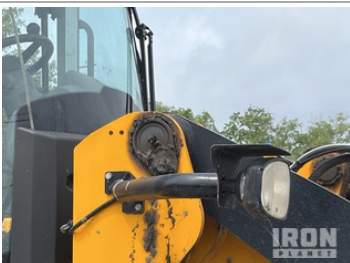
Chassis to Arm Pins	★★★★☆

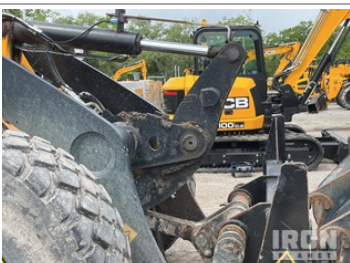
Tilt Linkage	★★★★☆

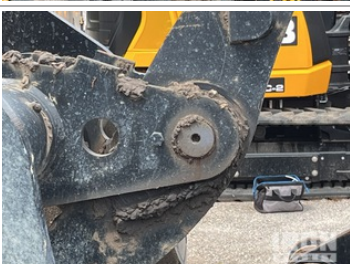
Tilt Linkage Pins and Bushings	★★★★☆

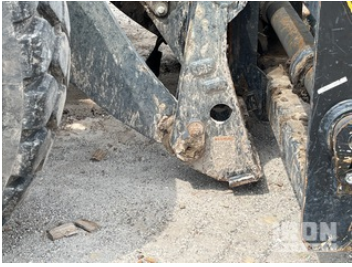
Quick Coupler to Arms Pins	☆☆☆☆

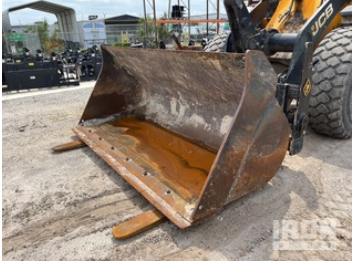
<b>Wheel Loader*</b>		
<b>Item</b>	<b>Assessment</b>	<b>Photo</b>
Loader Bucket Condition	★★★★☆

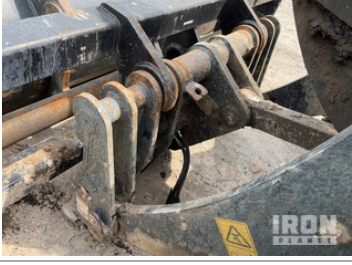
Loader Quick Coupler	★★★★☆ paladin Coupler, Operational

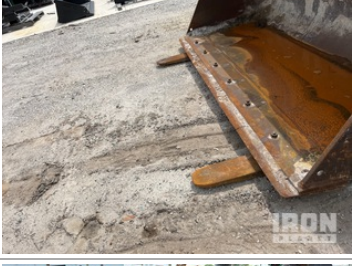
Forks	★★★★☆
