## Item #13177108 - 2021 Volvo EC750E Tracked Excavator

# Inspection Report

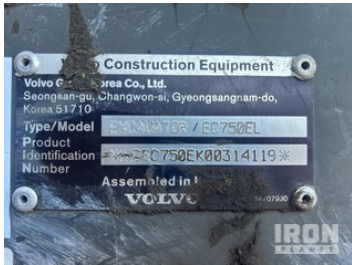
| Serial Number / VIN | 314119 | |

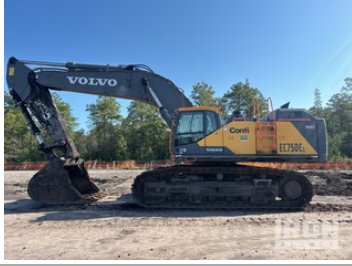
| Body Panels | No visible damage or missing components | |

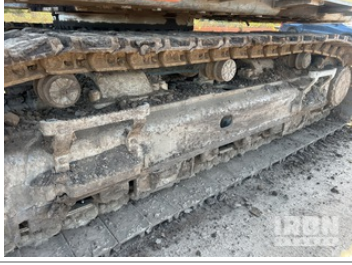
| Steps | No visible damage or missing components | |

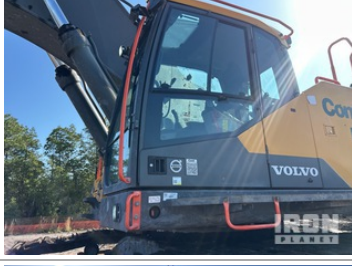
| Hand Rails | No visible damage or missing components | |

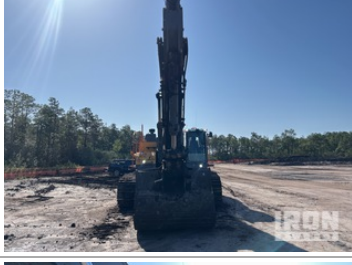
| Exterior Lights | All lights operational | |

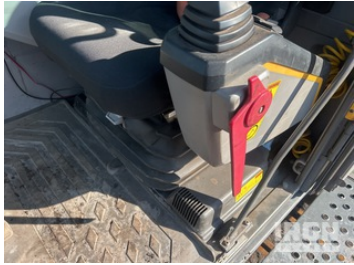
| Item | Assessment | Photo |
|---|---|---|
| Safety Lock Out/Stop | Operational | |

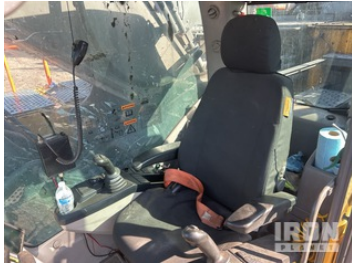
| Item | Assessment | Photo |
|---|---|---|
| Seat/Armrests | No visible damage or missing components | |

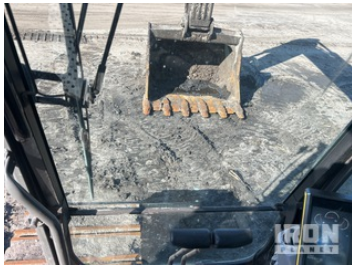
| Item | Assessment | Photo |
|---|---|---|
| Glass | No visible damage or missing components | |

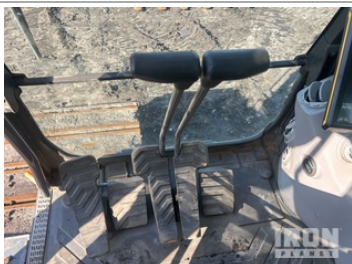
| Item | Assessment | Photo |
|---|---|---|
| Steering Controls | ★★★★☆ | |

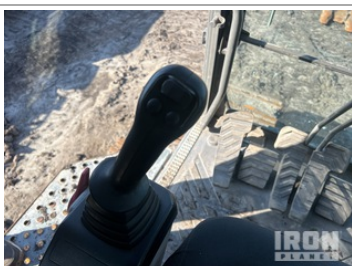
| Item | Assessment | Photo |
|---|---|---|
| Hydraulic Controls | ★★★★☆ | |

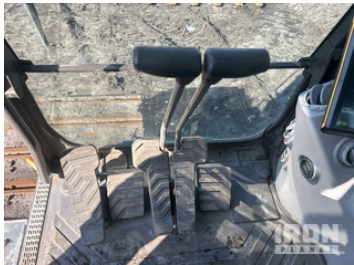
| Drivetrain Controls | ★★★★☆ | |

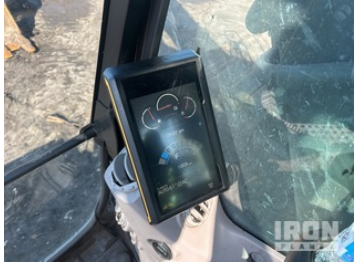
| Dash Console | ★★★★☆ | |

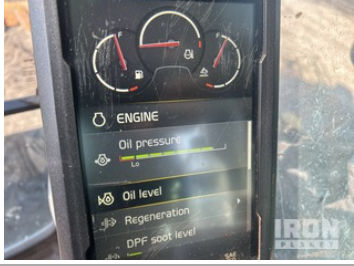
| Engine Oil Pressure | The gauge registers in the operating range. | |

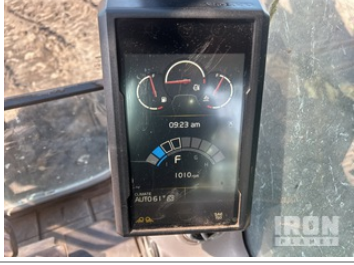
| Warning Lights | Operational | |

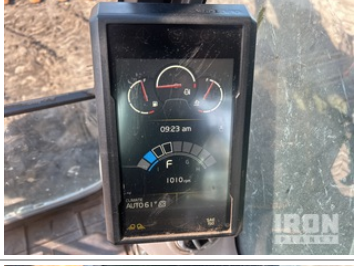
| Gauges | Operational | |

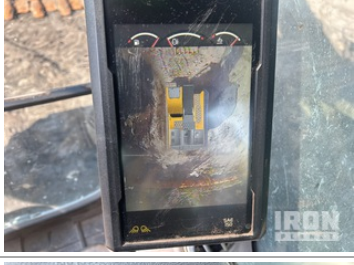
| Rear View Camera | Camera operates as intended | |

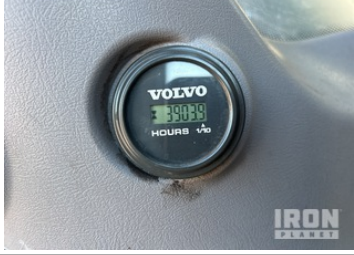
| Hour Meter / Odometer | 3903 hrs | |

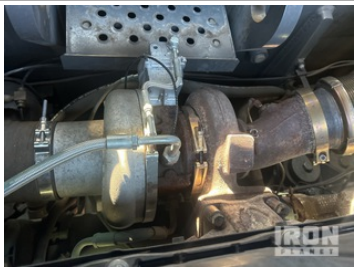
| Engine | | |
|---|---|---|
| Exhaust System | No visible damage or missing components | A photograph of the exhaust system, showing the turbocharger and various pipes. The word 'IRON' is visible in the bottom right corner of the photo. |

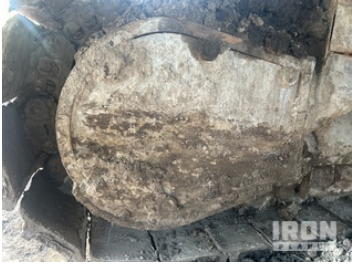
| Item | Assessment | Photo |
|---|---|---|
| Left Drive Motor | ★★★★☆ | A close-up photograph of the left drive motor, showing a large, dark, cylindrical component with a textured surface. The word "IRON" is visible in the bottom right corner of the image. |

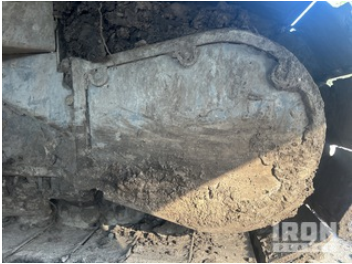
| Item | Assessment | Photo |
|---|---|---|
| Right Drive Motor | ★★★★☆ | A close-up photograph of the right drive motor, showing a large, dark, cylindrical component with a textured surface. The word "IRON" is visible in the bottom right corner of the image. |

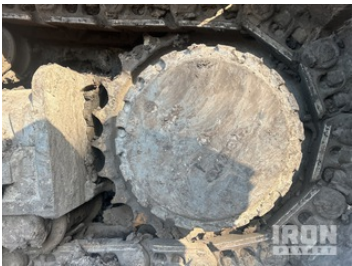
| Item | Assessment | Photo |
|---|---|---|
| Left Final Drive | ★★★★☆ | A close-up photograph of the left final drive, showing a large, dark, cylindrical component with a textured surface. The word "IRON" is visible in the bottom right corner of the image. |

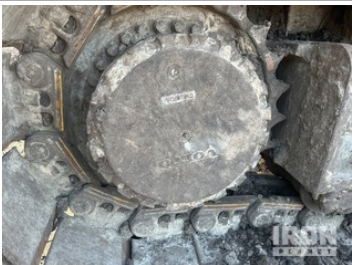
| Item | Assessment | Photo |
|---|---|---|
| Right Final Drive | ★★★★☆ | A close-up photograph of the right final drive, showing a large, dark, cylindrical component with a textured surface. The word "IRON" is visible in the bottom right corner of the image. |

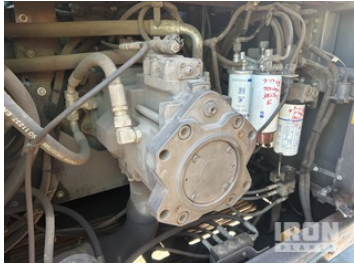
| Item | Assessment | Photo |
|---|---|---|
| Pumps (Hydraulics) | ★★★★☆ | |

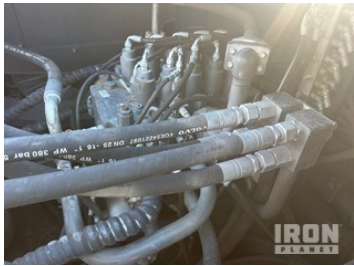
| Item | Assessment | Photo |
|---|---|---|
| Valves | ★★★★☆ | |

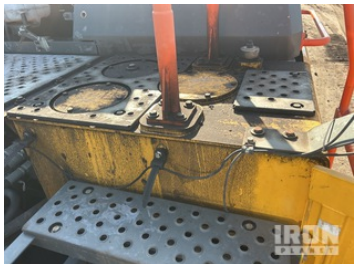
| Item | Assessment | Photo |
|---|---|---|
| Hydraulic Tank | ★★★★☆ | |

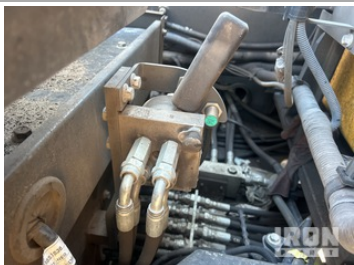
| Item | Assessment | Photo |
|---|---|---|
| Hydraulic Control Pattern Changer | ★★★★☆ | |

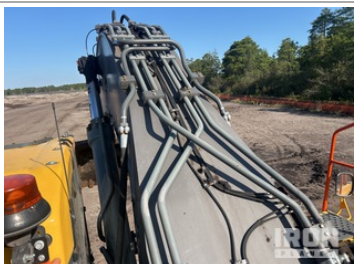
| Item | Assessment | Photo |
|---|---|---|
| Hoses (Hydraulics) | ★★★★☆ | |

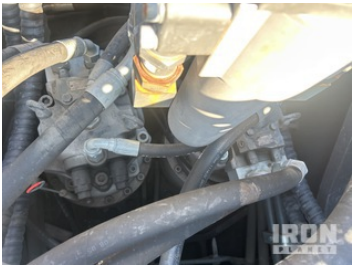
| Swing Motor | ★★★★☆ | |

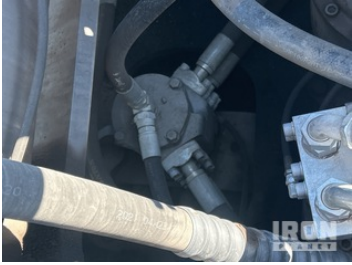
| Hydraulic Center Swivel | ★★★★☆ | |

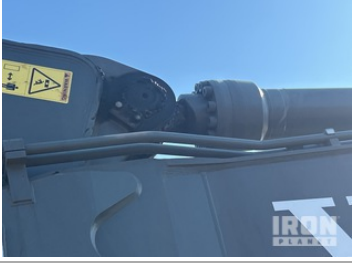
| Stick Cylinder | ★★★★☆ | |

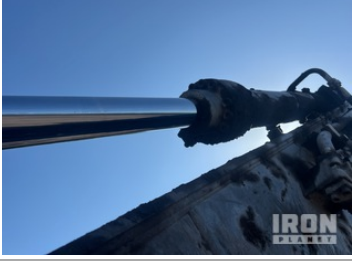
| Bucket Cylinder | ★★★★☆ | |

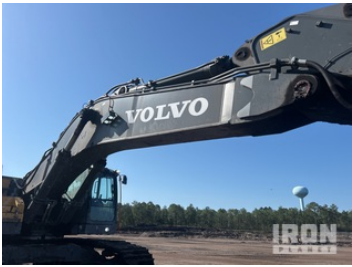
| Item | Assessment | Photo |
|---|---|---|
| Boom Condition | ★★★★☆ | |

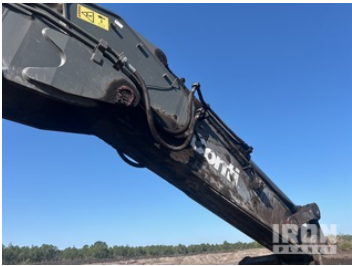
| Item | Assessment | Photo |
|---|---|---|
| Stick Condition | ★★★★☆ | |

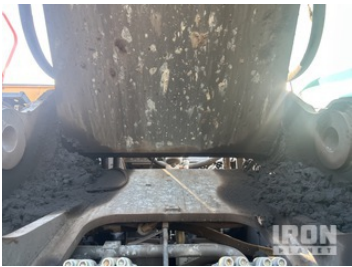
| Item | Assessment | Photo |
|---|---|---|
| Boom Base Pin and Bushings | ★★★★☆ | |

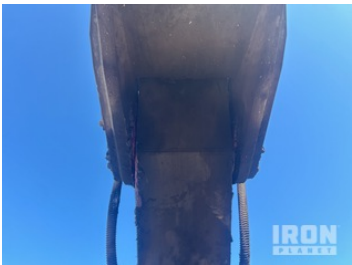
| Item | Assessment | Photo |
|---|---|---|
| Pin and Bushings Boom to Stick | ★★★★☆ | |

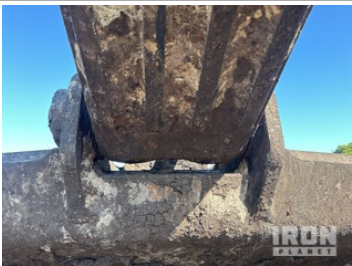
| Item | Assessment | Photo |
|---|---|---|
| Pin and Bushings Stick to Bucket | ★★★★☆ | |

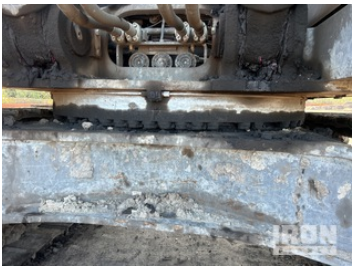
| Item | Assessment | Photo |
|---|---|---|
| Turntable Bearing | ★★★★☆ | |

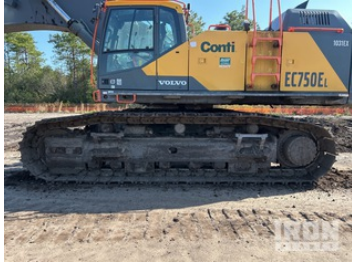
| Item | Assessment | Photo |
|---|---|---|
| Left Roller Frame | ★★★★☆ | |

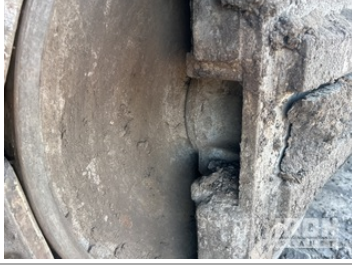
| Item | Assessment | Photo |
|---|---|---|
| Left Track Tensioner | ★★★★☆ | |

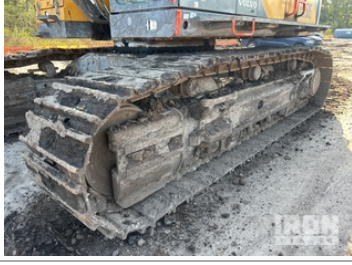
| Item | Assessment | Photo |
|---|---|---|
| Left Track Pads | ★★★★☆<br>35.5 in Wide Double Grouser | |

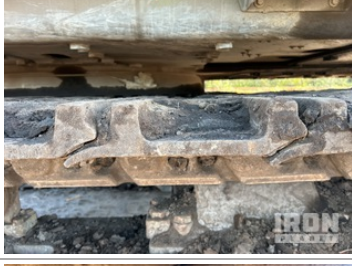
| Item | Assessment | Photo |
|---|---|---|
| Left Grouser Height | 47 mm | |

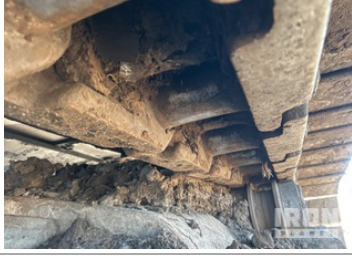
| Item | Assessment | Photo |
|---|---|---|
| Left Track Bushings | 84 mm | |

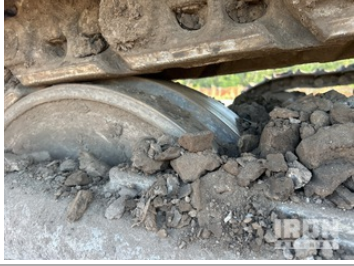
| Left Idler | 25 mm | |

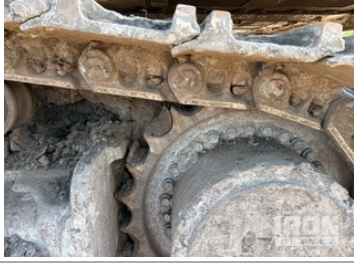
| Left Sprocket | ★★★★☆ | |

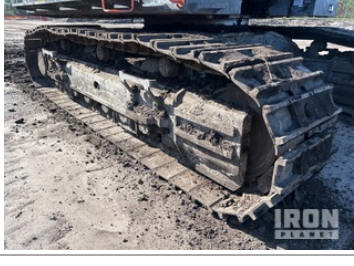
| Right Track Pads | ★★★★☆<br>35.5 in Wide Double Grouser | |

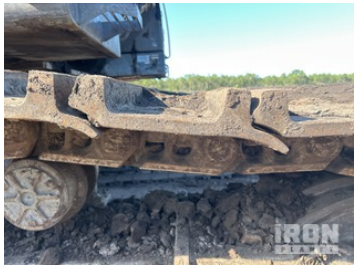
| Right Grouser Height | 46 mm | |

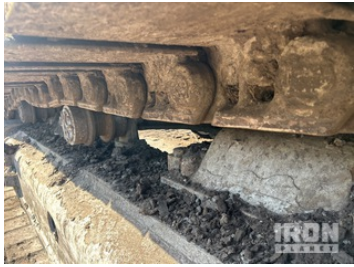
| Right Track Links | 147 mm | |

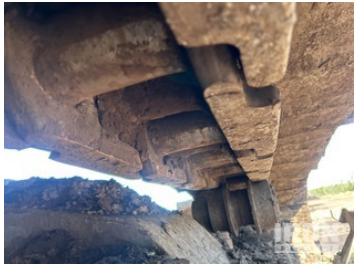
| Right Track Bushings | 83 mm | |

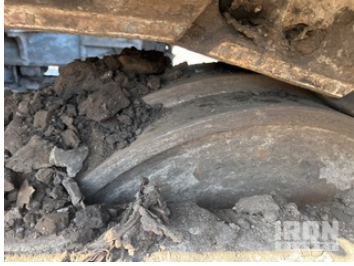
| Right Idler | 26 mm | |

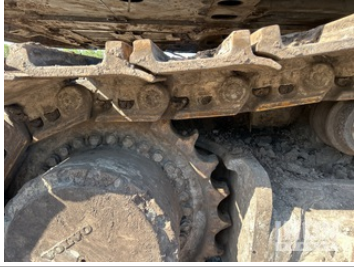
| Right Sprocket | ★★★★☆ | |

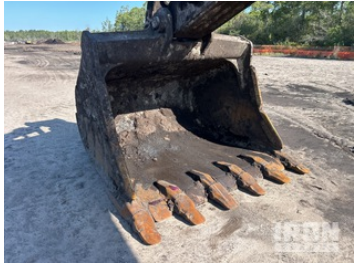
| Specialty | | |
|---|---|---|
| Excavator Bucket Condition | ★★★★☆ | |

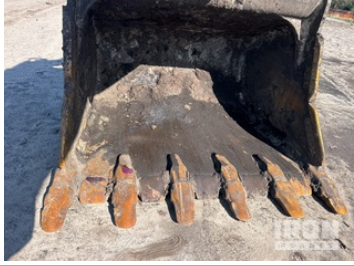
| Specialty | | |
|---|---|---|
| Bucket Cutting Edge/Shanks/Teeth | ★★★★☆<br>No visible damage or missing components | |
