## Item #12840166 - 2021 Astec GT125 Tracked Crushing Plant

# Inspection Report

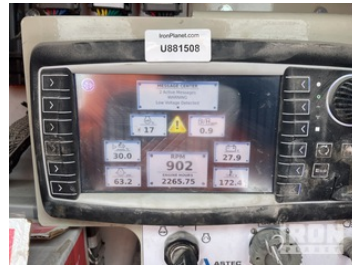
Hour Meter / Odometer

2265 hrs

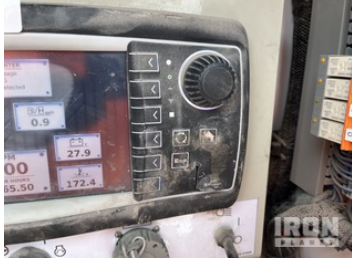
Engine Controls	★★★★☆

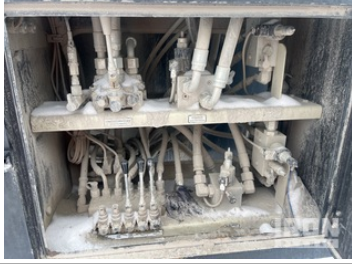
Crusher/Screen Controls	★★★★☆

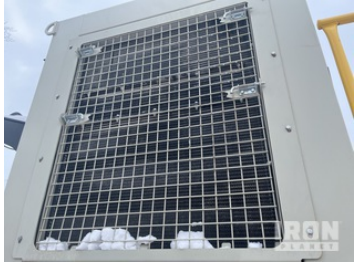
Radiator	★★★★☆

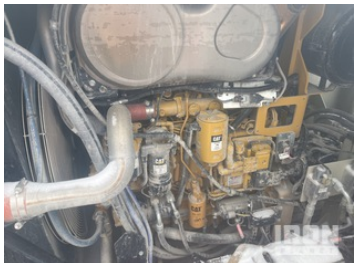
Oil Leaks	No dripping leaks	
Fuel Leaks	No dripping leaks	
Cooling System Leaks	No dripping leaks	
Engine - Left Side

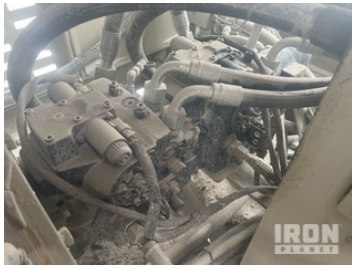
<b>Hydraulics</b>		
See photos for condition		
<b>Item</b>	<b>Assessment</b>	<b>Photo</b>
Pumps (Hydraulics)	★★★★☆

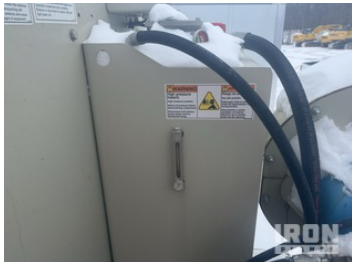
Hydraulic Tank	★★★★☆

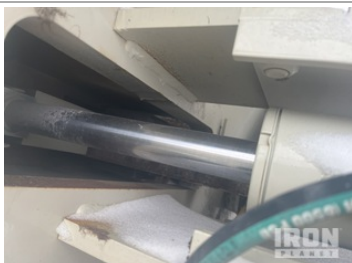
Crusher Door Cylinders	★★★★☆

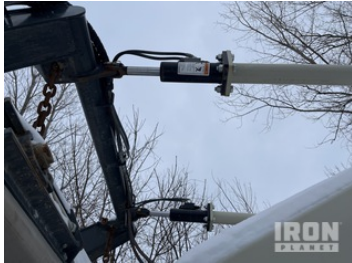
Conveyor Cylinders	★★★★☆

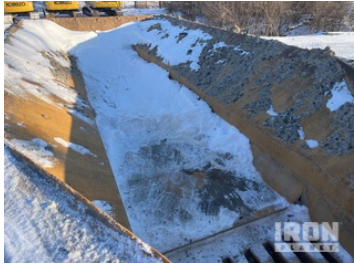
Chassis		
Item	Assessment	Photo
Feed Hopper	<p>★★★★☆ Length @ top: 13', Width @ top: 7'</p>

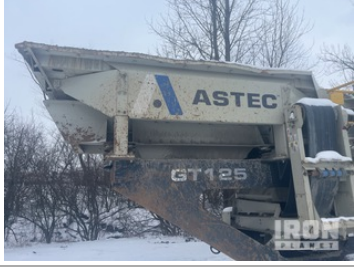
Crusher Base Frame	<p>★★★★☆</p>

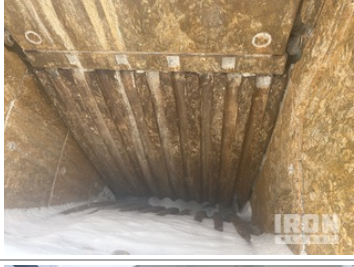
Jaw, Blow Bar and Anvil Wear Surface	<p>★★★★☆</p>

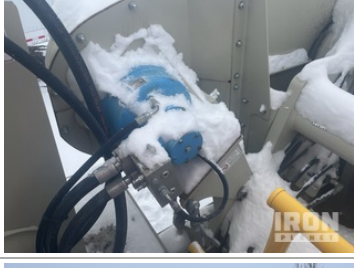
Crusher Drive System	<p>★★★★☆</p>

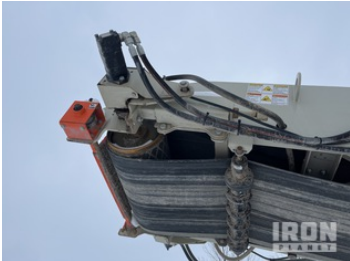
Discharge Conveyor Drive Motor	Operational, Belts appear to be frozen. Briefly engaged in forward and reverse, but did not fully rotate

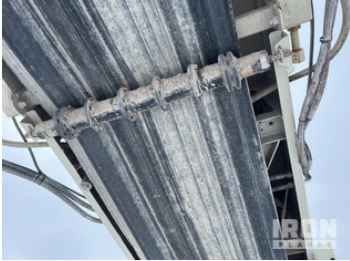
Discharge Conveyor Rollers	★★★★☆

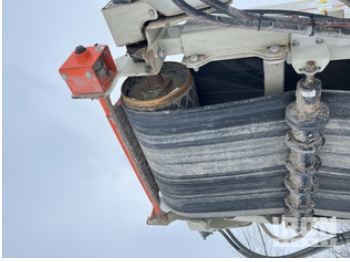
Discharge Conveyor Head and Tail Pulley	★★★★☆

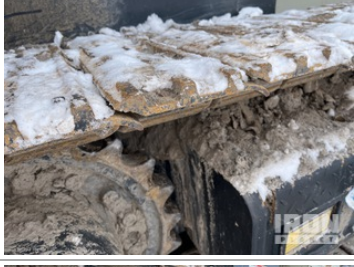
Left Grouser Height	17 mm

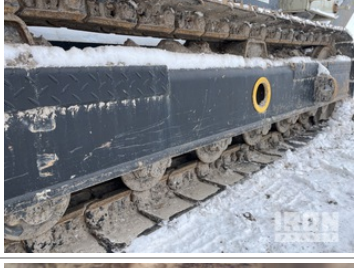
Left Track Bushings	Bushings have not been turned

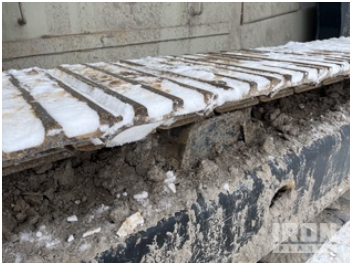
Right Grouser Height	17 mm

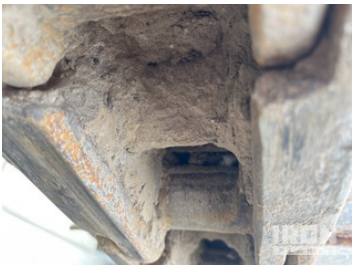
Right Track Bushings	Bushings have not been turned
