## Item #14954803 - 2021 Gradall XL4100V Highway Wheeled Excavator

# Inspection Report

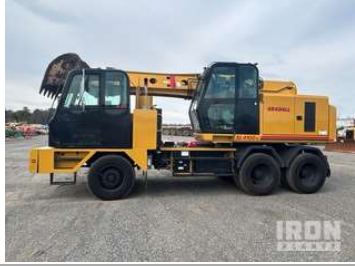
| Body Panels | No visible damage or missing components | |

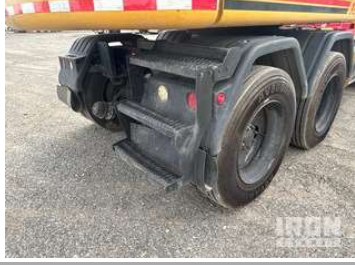
| Steps | No visible damage or missing components | |

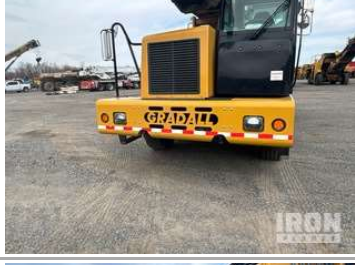
| Exterior Lights | All lights operational | |

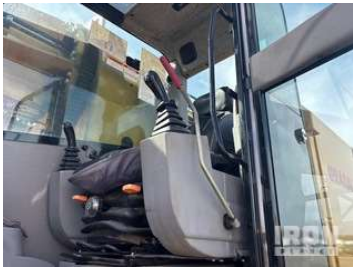
| Item | Assessment | Photo |
|---|---|---|
| Safety Lock Out/Stop | Operational | |

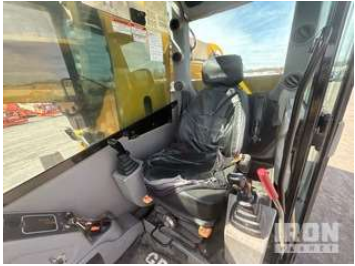
| Seat/Armrests | No visible damage or missing components | |

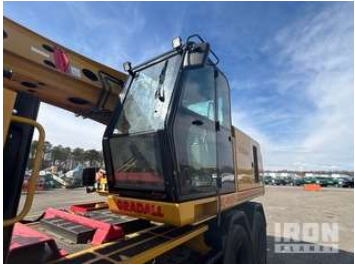
| Glass | No visible damage or missing components | |

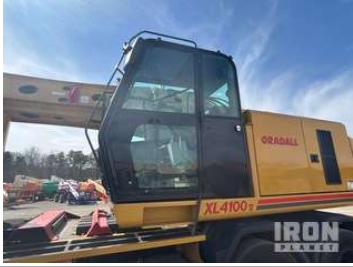
| Cab Door | No visible damage or missing components | |

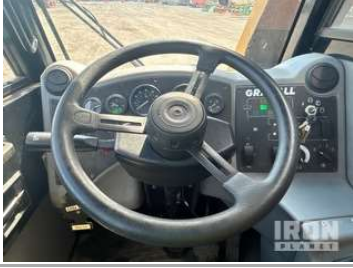
| Steering Controls | ★★★★☆ | |

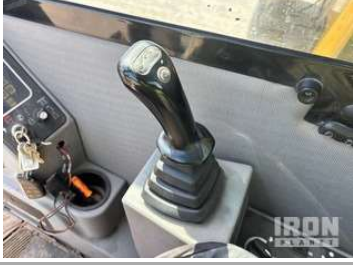
| Hydraulic Controls | ★★★★☆ | |

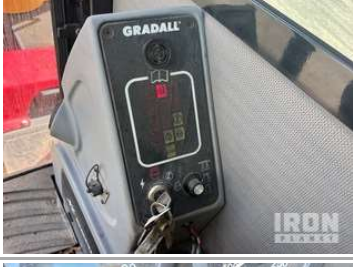
| Dash Console | ★★★★☆ | |

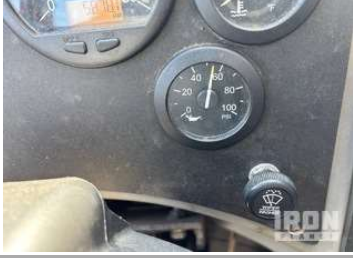
| Engine Oil Pressure | The gauge registers in the operating range. | |

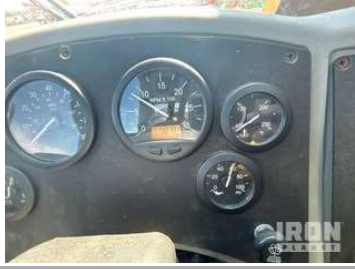
| Gauges | Operational | |

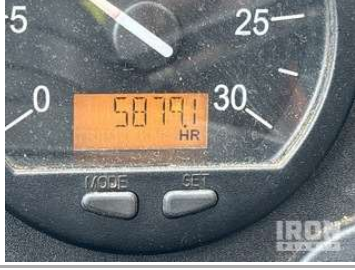
| Hour Meter / Odometer | 5879 hrs | |

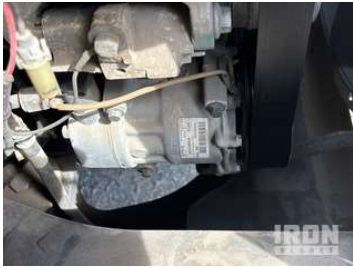
| A/C Compressor | Operational | |

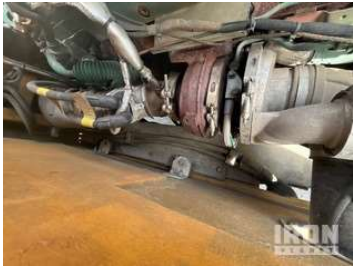
| Exhaust System | No visible damage or missing components | |

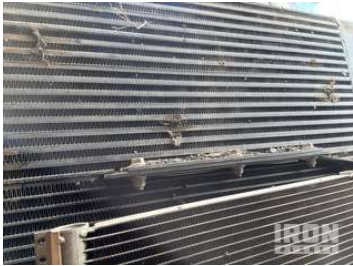
| Radiator | ★★★★☆ | |

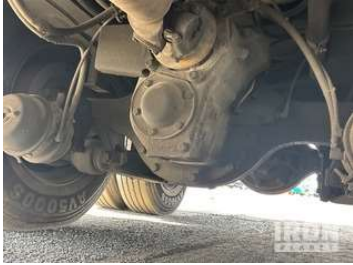
| Item | Assessment | Photo |
|---|---|---|
| Front Drive Axle | ★★★★☆ | A close-up photograph of the front drive axle assembly, showing the axle housing, differential, and suspension components. The image is taken from a low angle, looking up at the axle. |

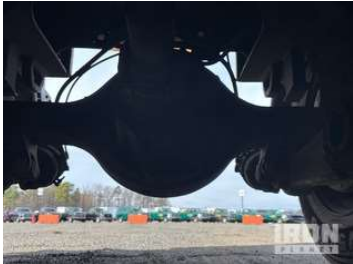
| Item | Assessment | Photo |
|---|---|---|
| Rear Drive Axle | ★★★★☆ | A photograph of the rear drive axle assembly, showing the axle housing, differential, and suspension components. The image is taken from a low angle, looking up at the axle. |

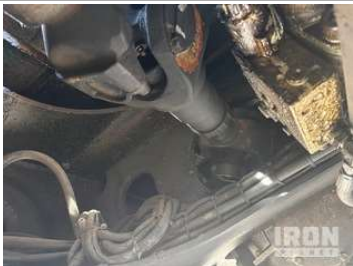
| Item | Assessment | Photo |
|---|---|---|
| Drive Line | ★★★★☆ | A photograph of the drive line components, showing the drive shaft, yokes, and universal joints. The image is taken from a low angle, looking up at the drive line. |

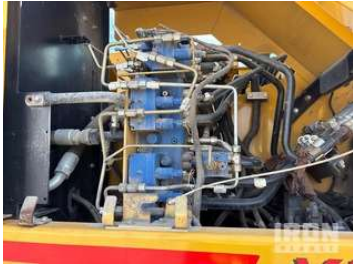
| Item | Assessment | Photo |
|---|---|---|
| Valves | ★★★★★ | |

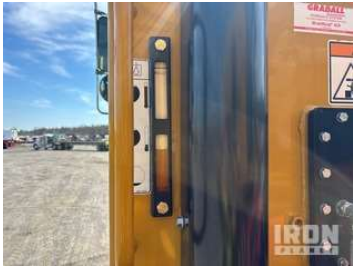
| Item | Assessment | Photo |
|---|---|---|
| Hydraulic Tank | ★★★★★ | |

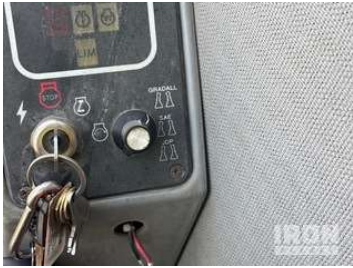
| Item | Assessment | Photo |
|---|---|---|
| Hydraulic Control Pattern Changer | ★★★★★ | |

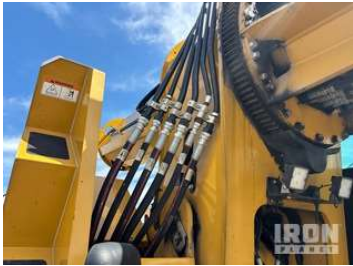
| Item | Assessment | Photo |
|---|---|---|
| Hoses (Hydraulics) | ★★★★★ | |

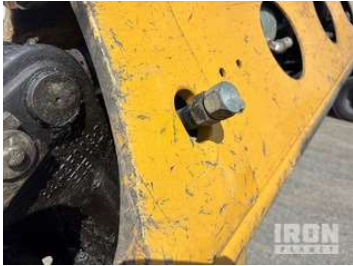
| Item | Assessment | Photo |
|---|---|---|
| Auxiliary Hydraulic Plumbing | Capped off, Not operationally checked,<br>End of boom | |

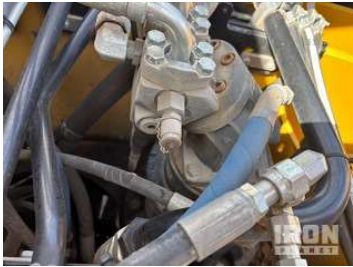
| Swing Motor | ★★★★☆ | |

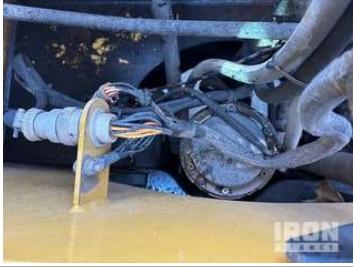
| Hydraulic Center Swivel | ★★★★☆ | |

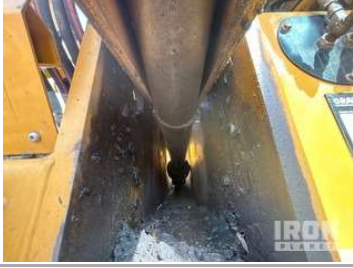
| Boom Lift Cylinder(s) | ★★★★☆ | |

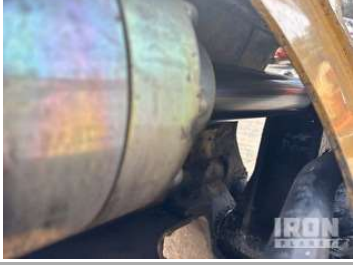
| Bucket Cylinder | ★★★★☆ | |

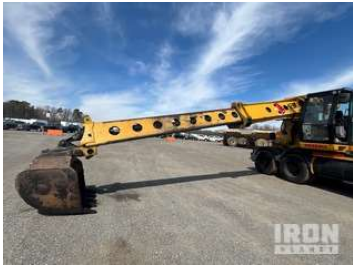
| Boom Condition | ★★★★☆ | |

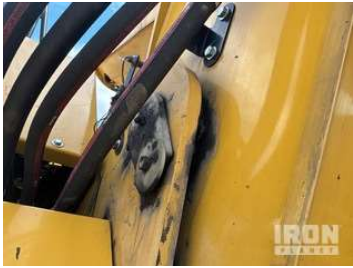
| Boom Base Pin and Bushings | ★★★★☆ | |

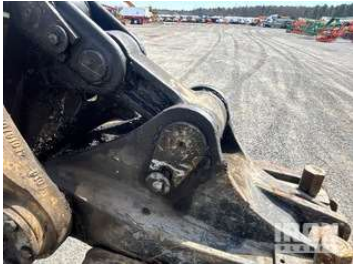
| Pin and Bushings Stick to Bucket | ★★★★☆ | |

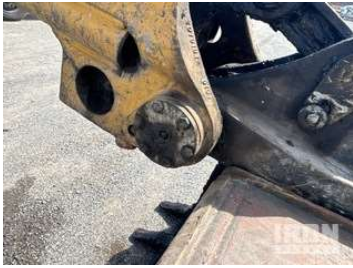
| Pins and Bushings Stick to Coupler | ★★★★☆ | |

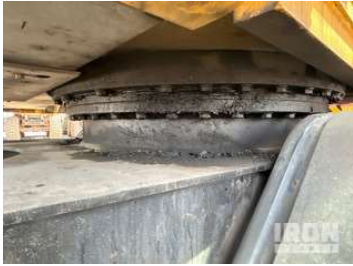
| Turntable Bearing | ★★★★☆ | |

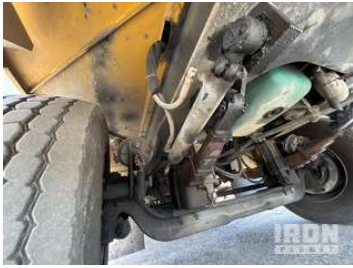
| Item | Assessment | Photo |
|---|---|---|
| Steering Linkage | ★★★★☆ | |

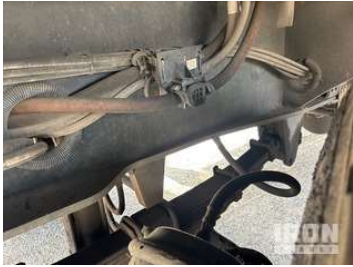
| Item | Assessment | Photo |
|---|---|---|
| Frame Condition | ★★★★☆ | |

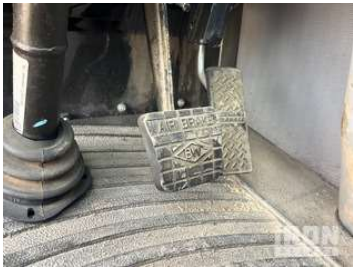
| Item | Assessment | Photo |
|---|---|---|
| Brake Control | ★★★★☆ | |

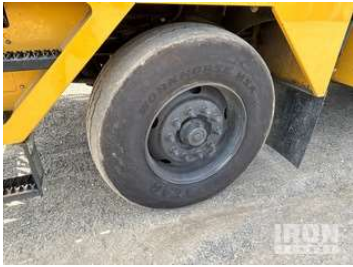
| Item | Assessment | Photo |
|---|---|---|
| Left Front Tire | Size: 385/65R22.5 Brand: Good year Model: Workhorse MSA Tread Depth: 8/32 | |

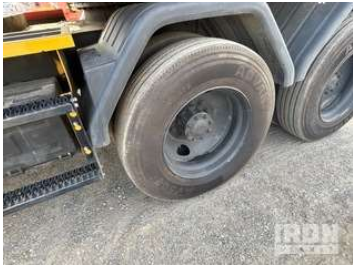
| Item | Assessment | Photo |
|---|---|---|
| Left Rear Tire | Size: 11R24.5 Brand: ADVANTA Model: AV5000S Tread Depth: LFO:16, LFI:15, LRO:16, LRI:16/32 | |

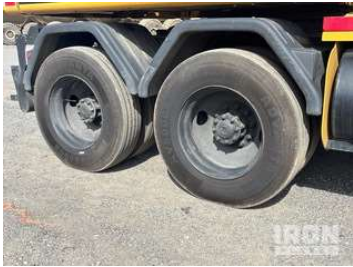
| Right Rear Tire | Size: 11R24.5 Brand: ADVANTA Model: AV5000S Tread Depth: RFO:15, RFI:12, RRO:16, RRI:15/32 | |

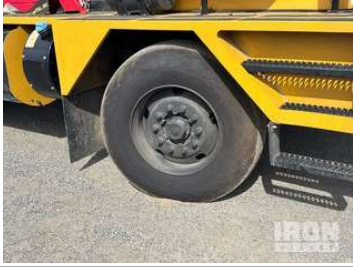
| Right Front Tire | Size: 385/65R22.5 Brand: GOODYEAR Model: WORKHORSE Tread Depth: 16/32 | |

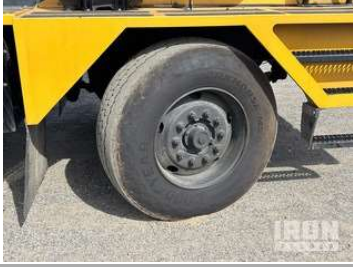
| Wheel Condition | No visible damage or missing components | |

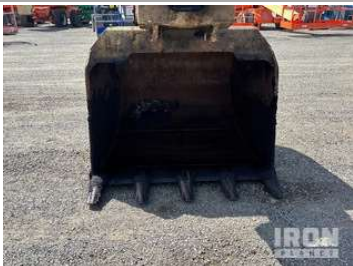
| Specialty | | |
|---|---|---|
| Excavator Bucket Condition | ★★★★☆ | |

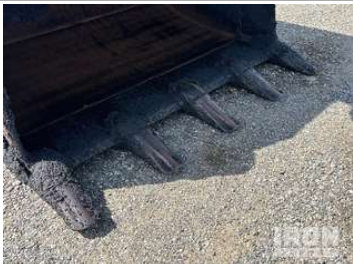
| Specialty | | |
|---|---|---|
| Bucket Cutting Edge/Shanks/Teeth | ★★★★☆ | |
