Item #11535314 - JCB 220XL 4F Tracked Excavator

Inspection Report

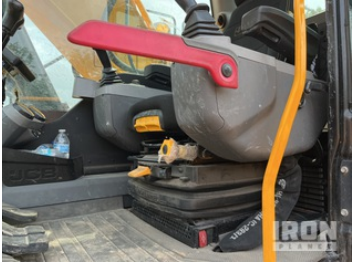
Safety		
Item	Assessment	Photo
Travel Alarm	Operational	
Horn	Operational	
Seat Belts	Operational	
Safety Lock Out/Stop	Operational

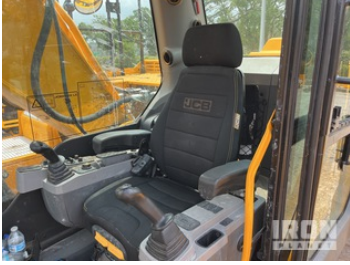
Control Station		
Item	Assessment	Photo
Seat/Armrests	No visible damage or missing components

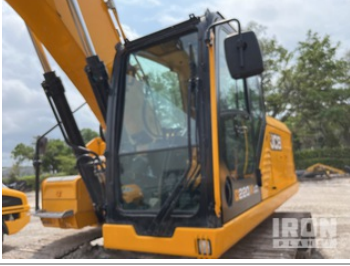
Glass	No visible damage or missing components

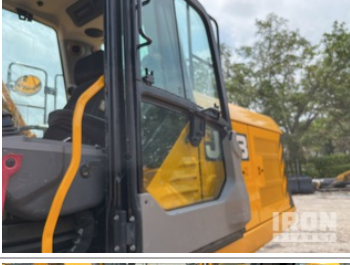
Cab Door	No visible damage or missing components

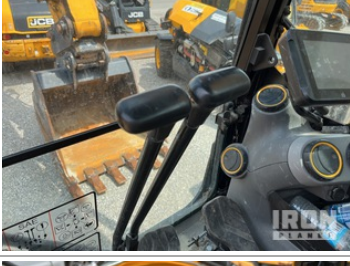
Steering Controls	★★★★☆

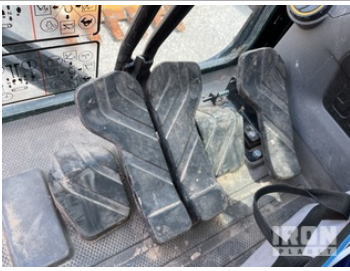
Drivetrain Controls	★★★★☆

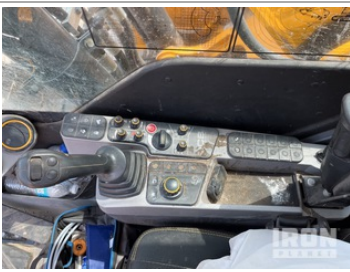
Dash Console	★★★★☆

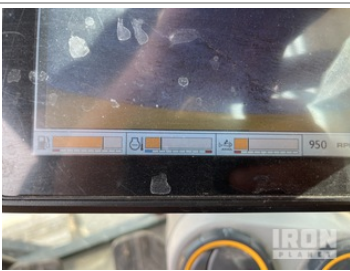
Gauges	Operational

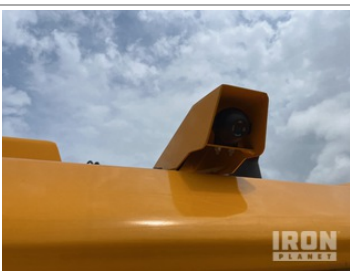
Rear View Camera	Camera operates as intended

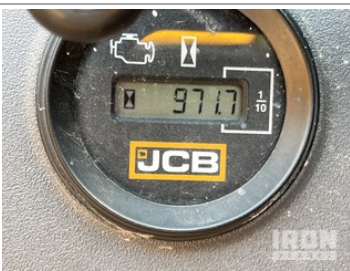
Hour Meter (pre-inspection)	971 hrs	
Hour Meter	971 hrs

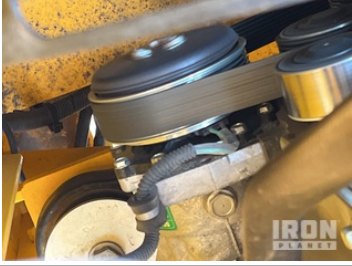
A/C Compressor	Operational

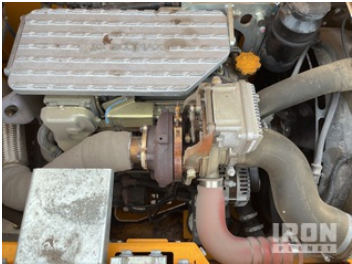
Starter	Operational	
Exhaust System	No visible damage or missing components

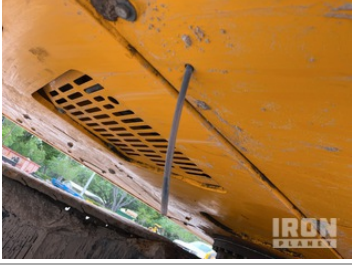
Oil Leaks	No dripping leaks

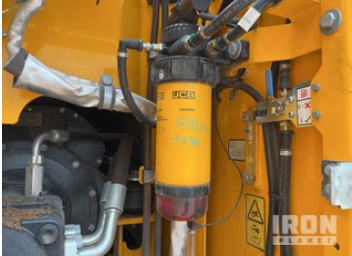
Fuel Leaks	No dripping leaks

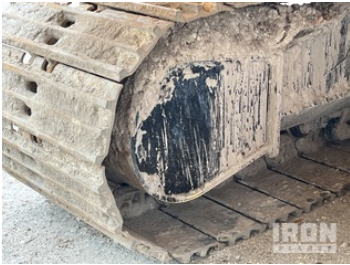
Drivetrain		
Operational test is limited to low speed in a confined flat area without load. Differential interlocks, full transmission shifting and functionality of all drive axles cannot be fully verified. Inspector listens for abnormal noises, observes leaks and notes physical damage.		
Item	Assessment	Photo
Left Drive Motor	★★★★☆

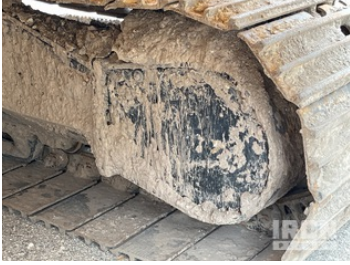
Right Drive Motor	★★★★☆

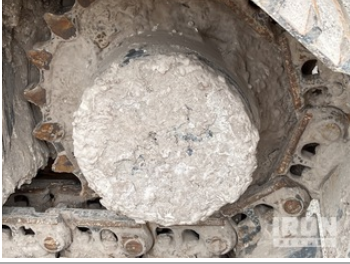
Left Final Drive	★★★★☆

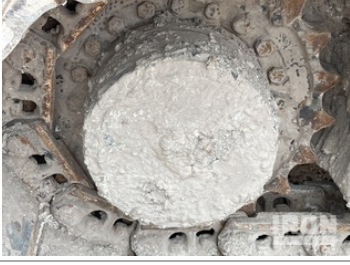
Right Final Drive	★★★★☆

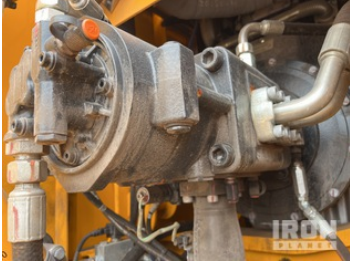
Hydraulics		
Item	Assessment	Photo
Pumps (Hydraulics)	★★★★☆

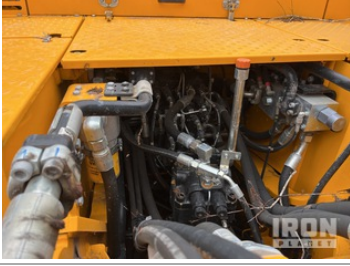
Valves	★★★★☆

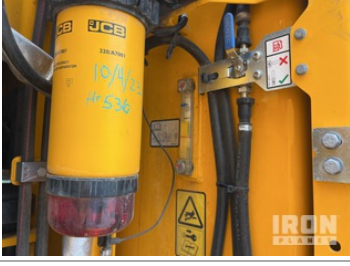
Hydraulic Tank	★★★★☆

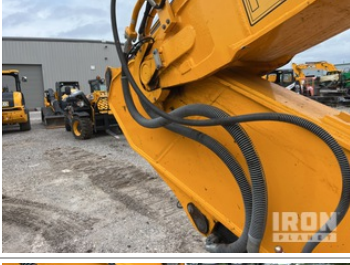
Hoses (Hydraulics)	★★★★☆

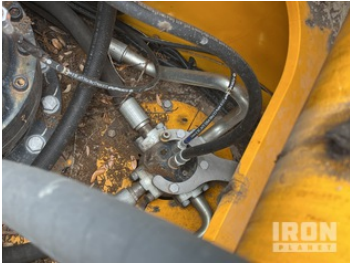
Hydraulic Center Swivel	★★★★☆

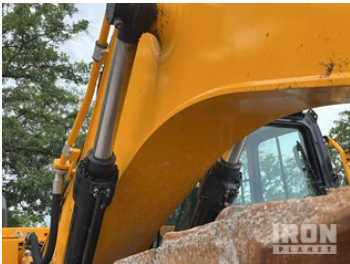
Boom Lift Cylinder(s)	★★★★☆

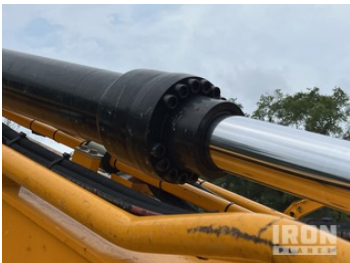
Stick Cylinder	★★★★☆

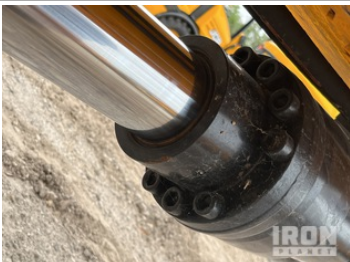
Bucket Cylinder	★★★★☆

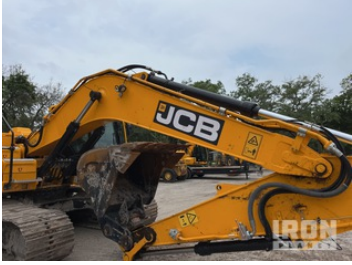
Chassis		
Item	Assessment	Photo
Boom Condition	★★★★☆

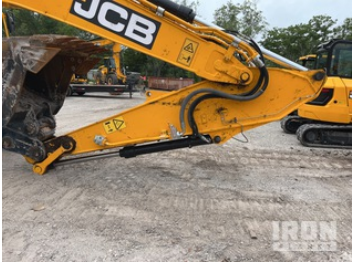
Stick Condition	★★★★☆

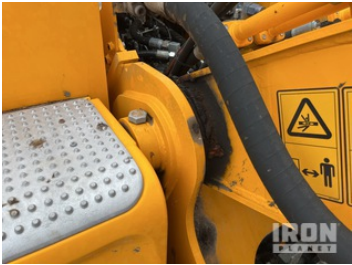
Boom Base Pin and Bushings	★★★★☆

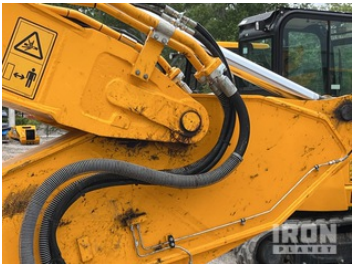
Pin and Bushings Boom to Stick	★★★★☆

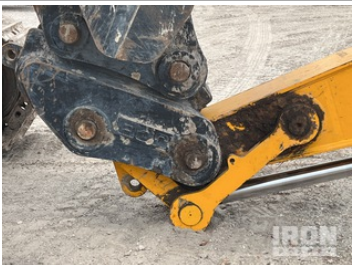
Pins and Bushings Stick to Coupler	★★★★☆

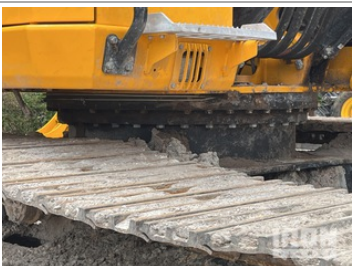
Turntable Bearing	★★★★☆

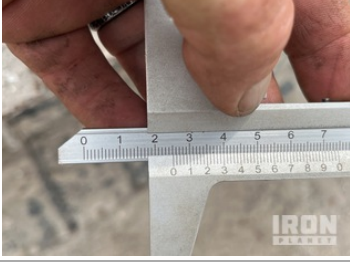
Left Grouser Height	30 mm

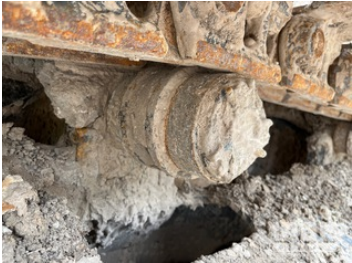
Left Carrier Rollers	#1 118 mm #2 119 mm

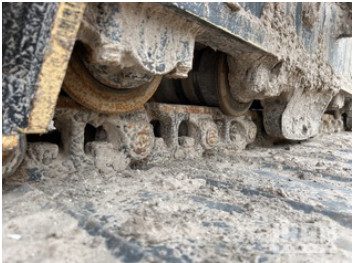
Left Bottom Rollers	#1 148 mm #2 148 mm #4 148 mm #5 148 mm #7 148 mm #8 148 mm

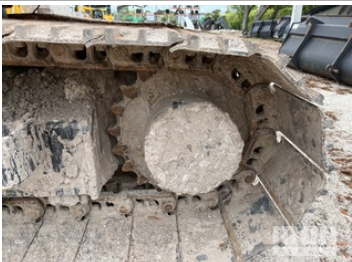
Left Sprocket	★★★★☆

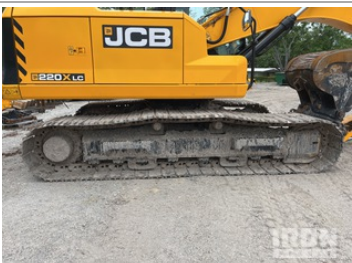
Right Roller Frame	★★★★☆

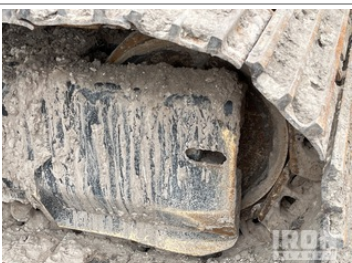
Right Track Tensioner	★★★★☆

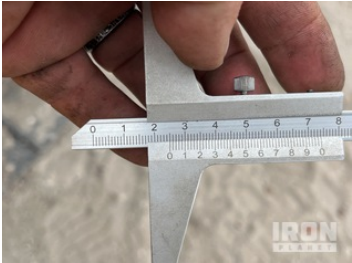
Right Grouser Height	29 mm

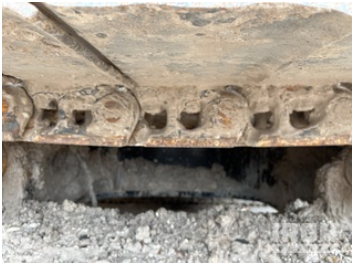
Right Track Links	195 mm

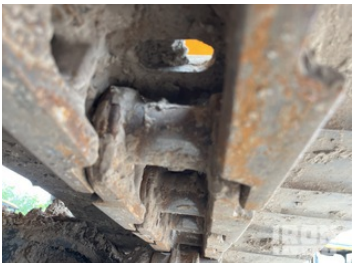
Right Track Bushings	58 mm

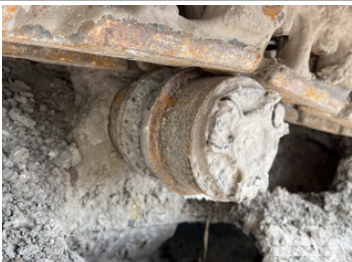
Right Carrier Rollers	#1 119 mm #2 118 mm

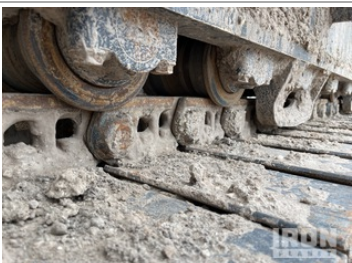
Right Bottom Rollers	#1 148 mm #2 148 mm #4 148 mm #5 148 mm #7 148 mm #8 148 mm

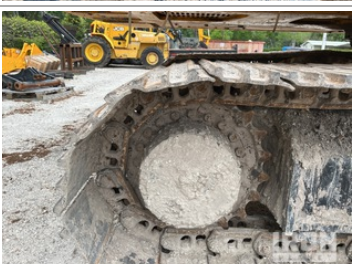
Right Sprocket	★★★★☆
