Item #11535316 - JCB 220XL 4F Tracked Excavator

Inspection Report

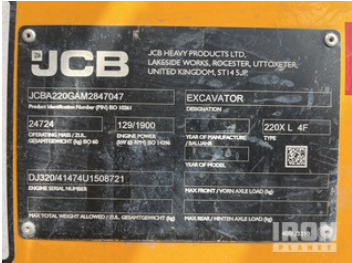
Serial Number / VIN	JCBA220GAM2847047

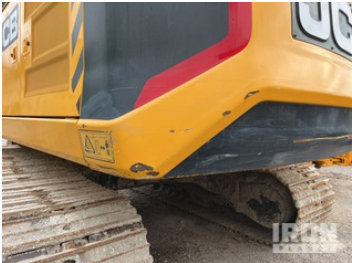
Paint	No visible damage

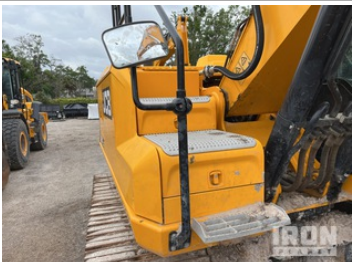
Steps	No visible damage or missing components

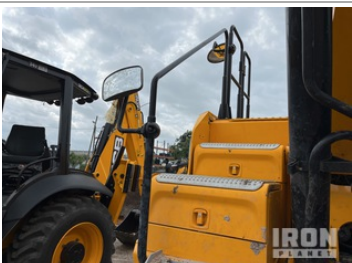
Hand Rails	No visible damage or missing components

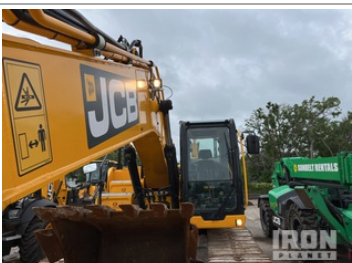
Exterior Lights	All lights operational

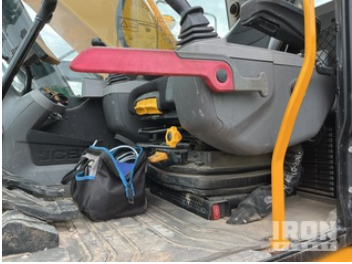
Safety		
Item	Assessment	Photo
Travel Alarm	Operational	
Horn	Operational	
Seat Belts	Operational	
Safety Lock Out/Stop	Operational

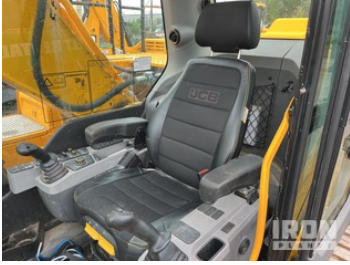
Control Station		
Item	Assessment	Photo
Seat/Armrests	No visible damage or missing components

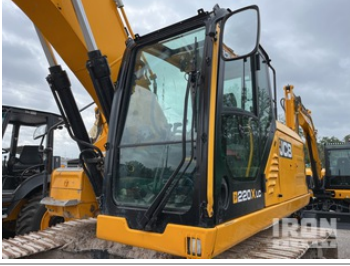
Glass	No visible damage or missing components

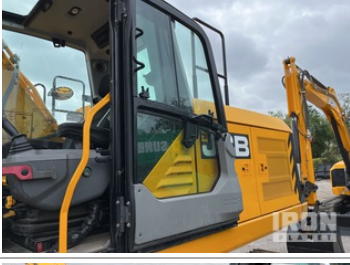
Cab Door	No visible damage or missing components

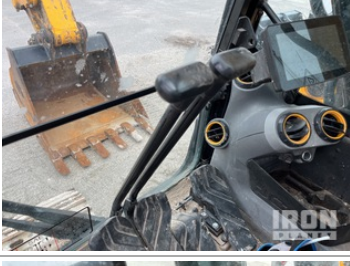
Steering Controls	★★★★☆

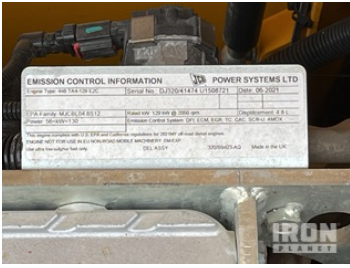
Engine		
Item	Assessment	Photo
Engine	2021 US EPA Label, Requires Diesel Exhaust Fluid	
Emission Label

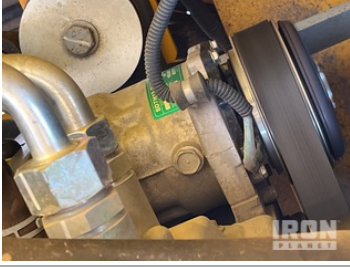
A/C Compressor	Operational

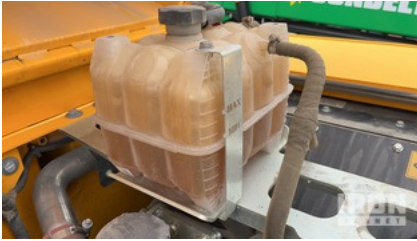
Radiator	★★★★☆

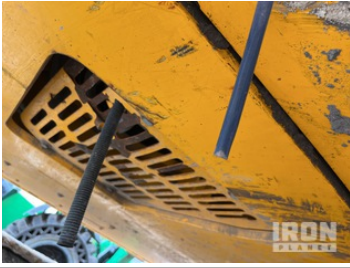
Oil Leaks	No dripping leaks

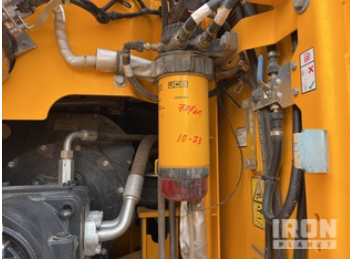
Fuel Leaks	No dripping leaks

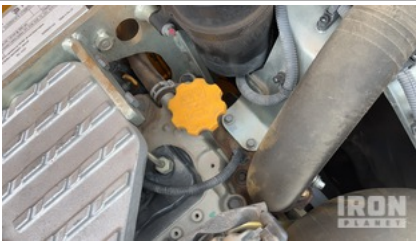
Cooling System Leaks	No dripping leaks

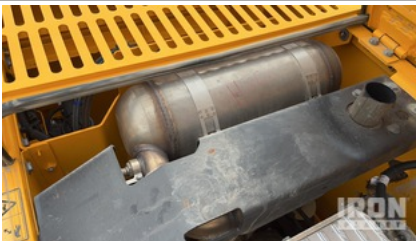
Limited Function Check	The engine started and ran.	
Engine #1

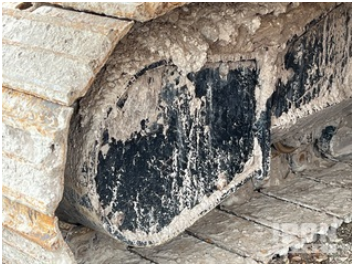
Drivetrain		
Operational test is limited to low speed in a confined flat area without load. Differential interlocks, full transmission shifting and functionality of all drive axles cannot be fully verified. Inspector listens for abnormal noises, observes leaks and notes physical damage.		
Item	Assessment	Photo
Left Drive Motor	★★★★☆

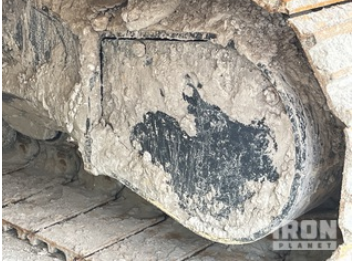
Right Drive Motor	★★★★☆

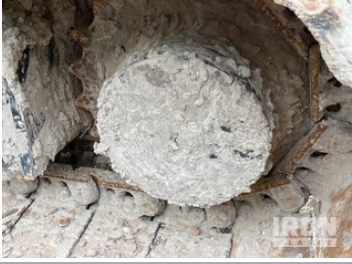
Left Final Drive	★★★★☆

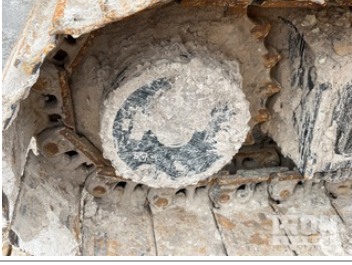
Right Final Drive	★★★★☆

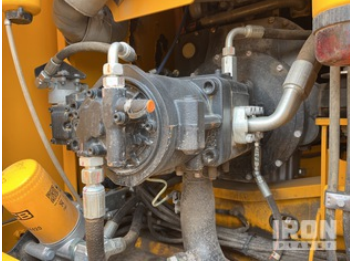
Hydraulics		
Item	Assessment	Photo
Pumps (Hydraulics)	★★★★☆

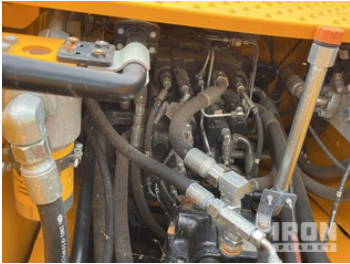
Valves	★★★★☆

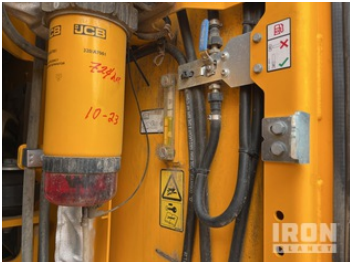
Hydraulic Tank	★★★★☆

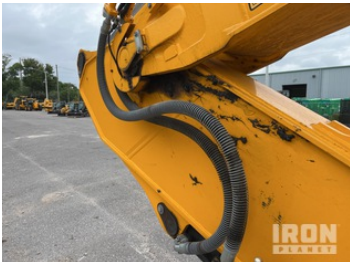
Hoses (Hydraulics)	★★★★☆

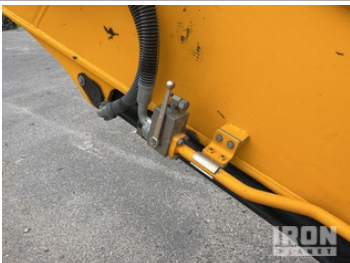
Auxiliary Hydraulic Plumbing	Not operationally checked, End of stick

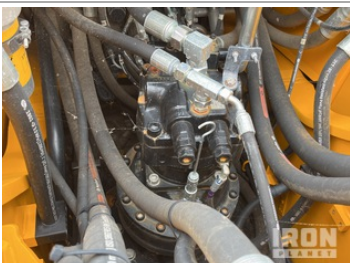
Swing Motor	★★★★☆

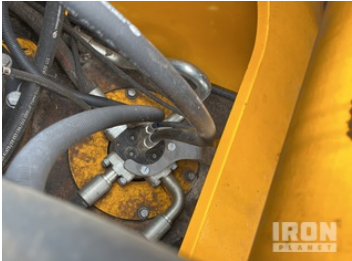
Hydraulic Center Swivel	★★★★☆

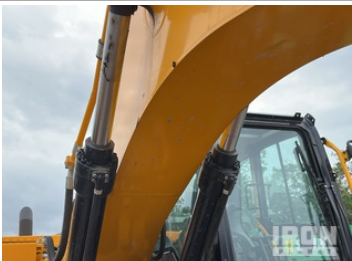
Boom Lift Cylinder(s)	★★★★☆

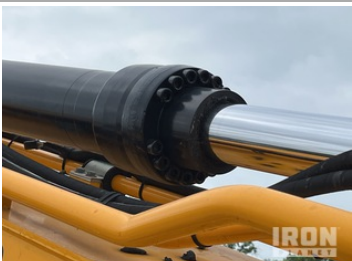
Stick Cylinder	★★★★☆

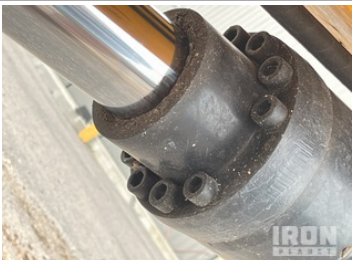
Bucket Cylinder	★★★★☆

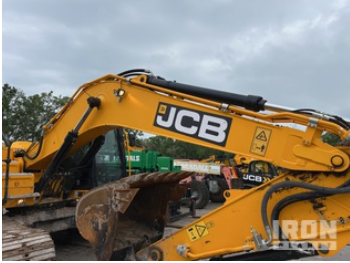
Chassis		
Item	Assessment	Photo
Boom Condition	★★★★☆

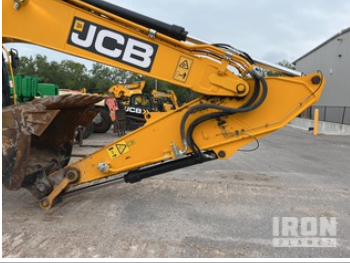
Stick Condition	★★★★☆

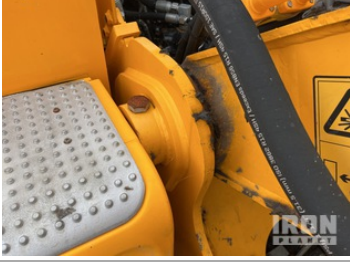
Boom Base Pin and Bushings	★★★★☆

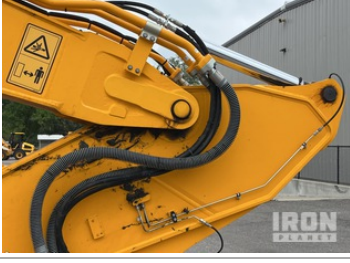
Pin and Bushings Boom to Stick	★★★★☆

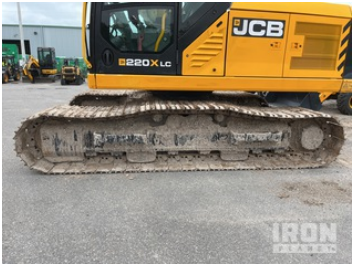
Undercarriage		
Undercarriage components photos (links, bushings, sprockets, idlers, rollers, grousers) are selected as representative. Bidders are encouraged to review photos using the zoom feature to judge condition in detail.		
Item	Assessment	Photo
Track Link Brand	Other No mark	
Left Roller Frame	★★★★☆

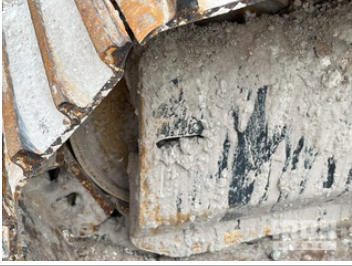
Left Track Tensioner	★★★★☆

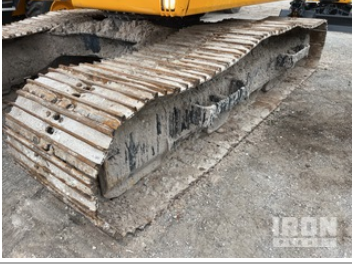
Left Track Pads	★★★★☆ 31.6 in Wide Triple Grouser

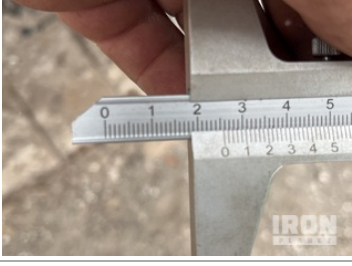
Left Grouser Height	25 mm

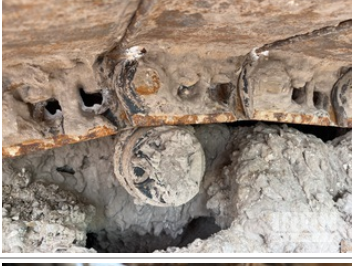
Left Track Links	105 mm

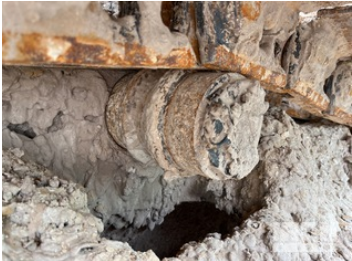
Left Carrier Rollers	#1 117 mm #2 118 mm

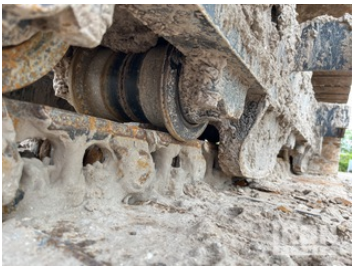
Left Bottom Rollers	#1 147 mm #2 148 mm #4 148 mm #5 148 mm #7 148 mm #8 148 mm

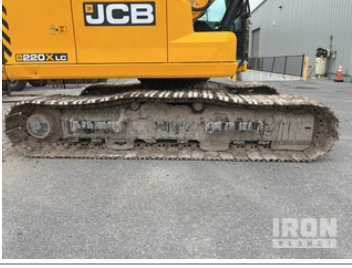
Right Roller Frame	★★★★

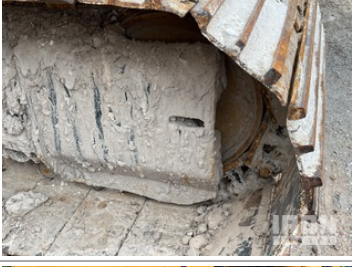
Right Track Tensioner	★★★★

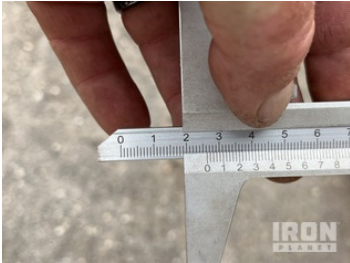
Right Grouser Height	26 mm

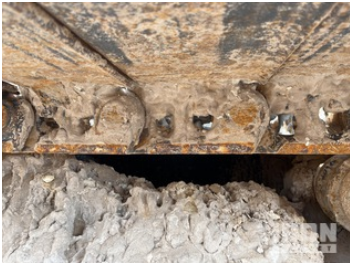
Right Track Links	105 mm

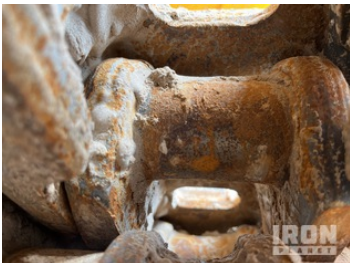
Right Track Bushings	58 mm

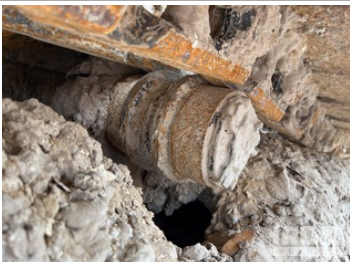
Right Carrier Rollers	#1 118 mm #2 117 mm

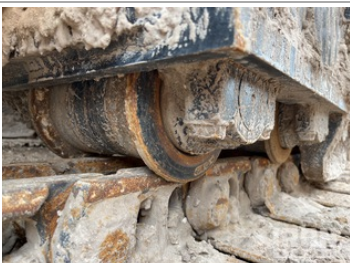
Right Bottom Rollers	#1 148 mm #2 148 mm #4 148 mm #5 148 mm #7 148 mm #8 148 mm

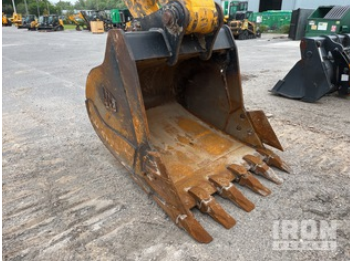
Specialty		
Item	Assessment	Photo
Excavator Bucket Condition	★★★☆☆
